Designation: C1942 – 24

Standard Practice for Evaluation of Low Angle Light Characteristics¹

1.1 This practice replicates low angle viewing conditions on ceramic tile installations.

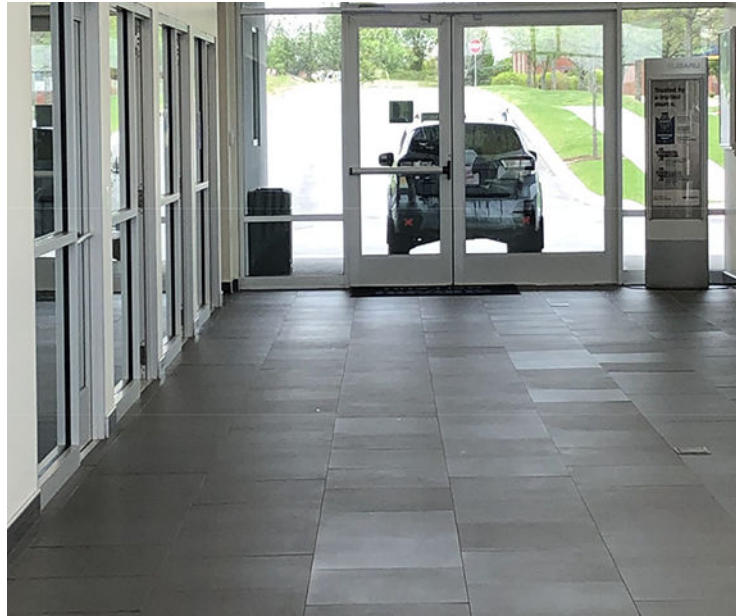
FIG. 1 Low Angle Light Defect Visible in an Installation

3.1.2.1 *Discussion*—When viewed at near vertical conditions (60° to 90°) the defect is typically not detectable. On lower gloss tiles this can be a checkerboard pattern (gloss difference) from tile to tile as shown by Fig. 1. Higher gloss (polished) tiles may exhibit specific defects under these conditions as described in Terminology F109.

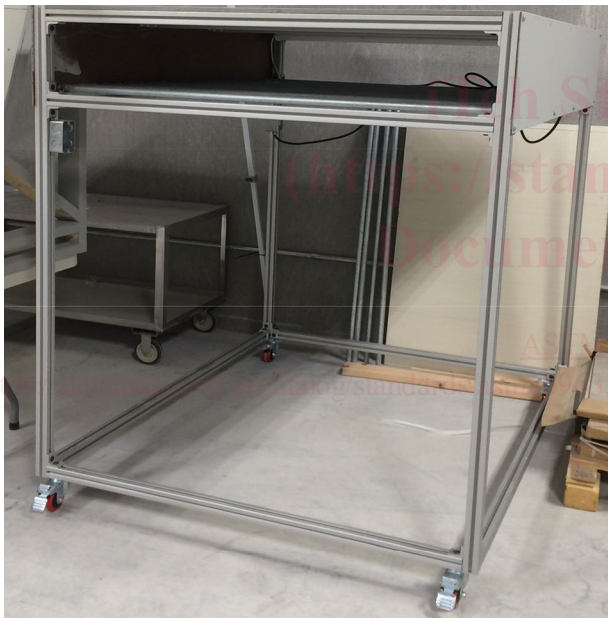
FIG. 2 Low Angle Light Viewing Box

5.2 The box shall be wide enough to accommodate at least two tiles being viewed, so length and width may vary. An opening of 6.0 in. \pm 1.0 in. (127 mm to 177.8 mm) that permits viewing of the product without directly observing the light source. An example is provided as Fig. 2.

5.4 *Light Source*, of sufficient strength to cast a strong diffused, light across the samples from the rear of the box. An 18W LED 24 in. fixture with 1350 lm and a color temperature of 5000 K was found to be sufficient for a 50 in. by 60 in. by 6 in. box shown in Fig. 2.
