**ISO
7146**

Plain bearings — Terms, characteristics and causes of damage and changes in appearance

ISO 7146:1993

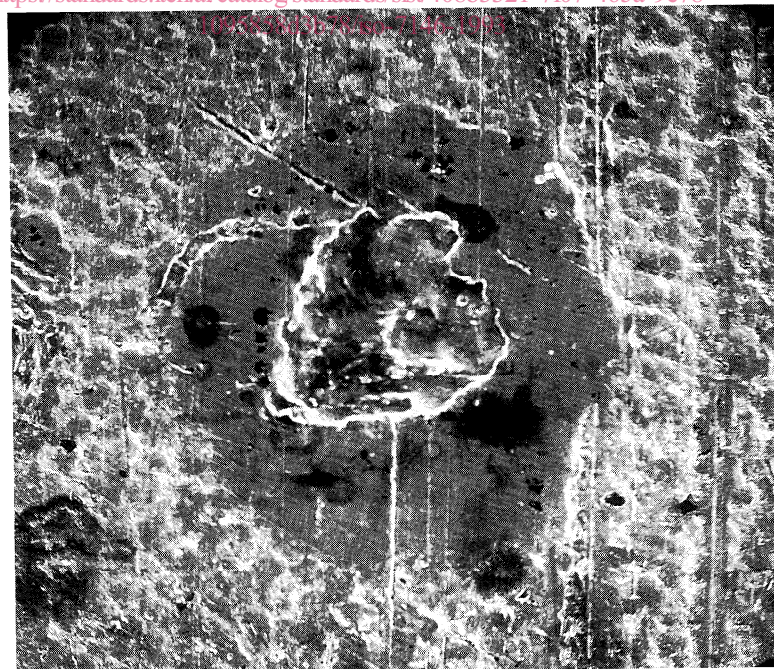
Figure 3 — Crater left by displaced foreign particle surrounded by reflective ring (halo) (typical of cause b illustrated in figure 1)

Material: steel/lead bronze/electroplated overlay
Magnification: x 50

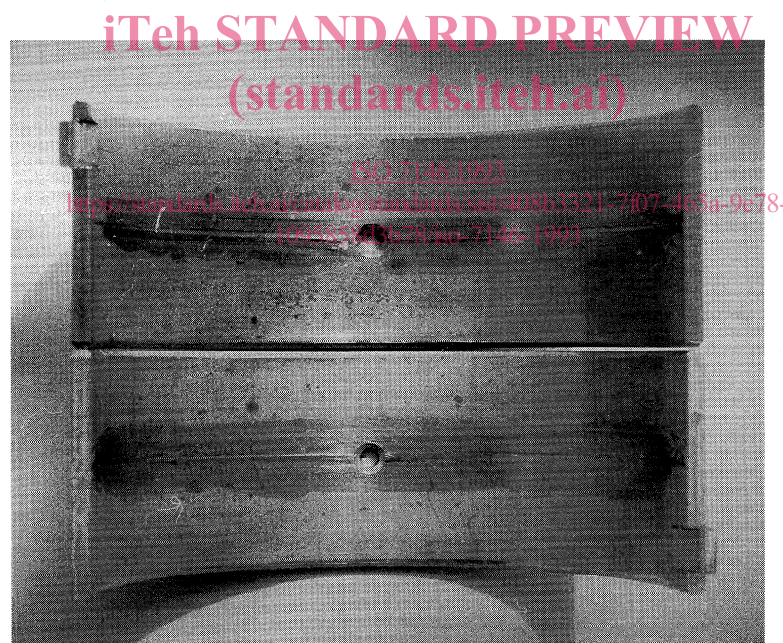
Figure 4 — Deep circumferential score with displaced bearing metal alongside

Material: steel/lead bronze/electroplated overlay
Magnification: x 1 (actual size)

NOTE — Score has been burnished by wear on this thin-walled bearing.

Scratches in the direction of motion. Deep scores or grooves may show displaced bearing metal alongside. Scores and grooves are burnished by wear (see figure 4).

This results in a highly reflective line on both sides of the groove, usually occurring in the most highly loaded region of the bearing, but occasionally around the entire circumference.

Contamination of the oil by large hard particles introduced during manufacture or commissioning (turnings), particles resulting from damage to other components due to poor maintenance, filter damage or bearing damage (fatigue, cavitation wear) to the same bearing or the bearing immediately preceding it in the oil supply system.

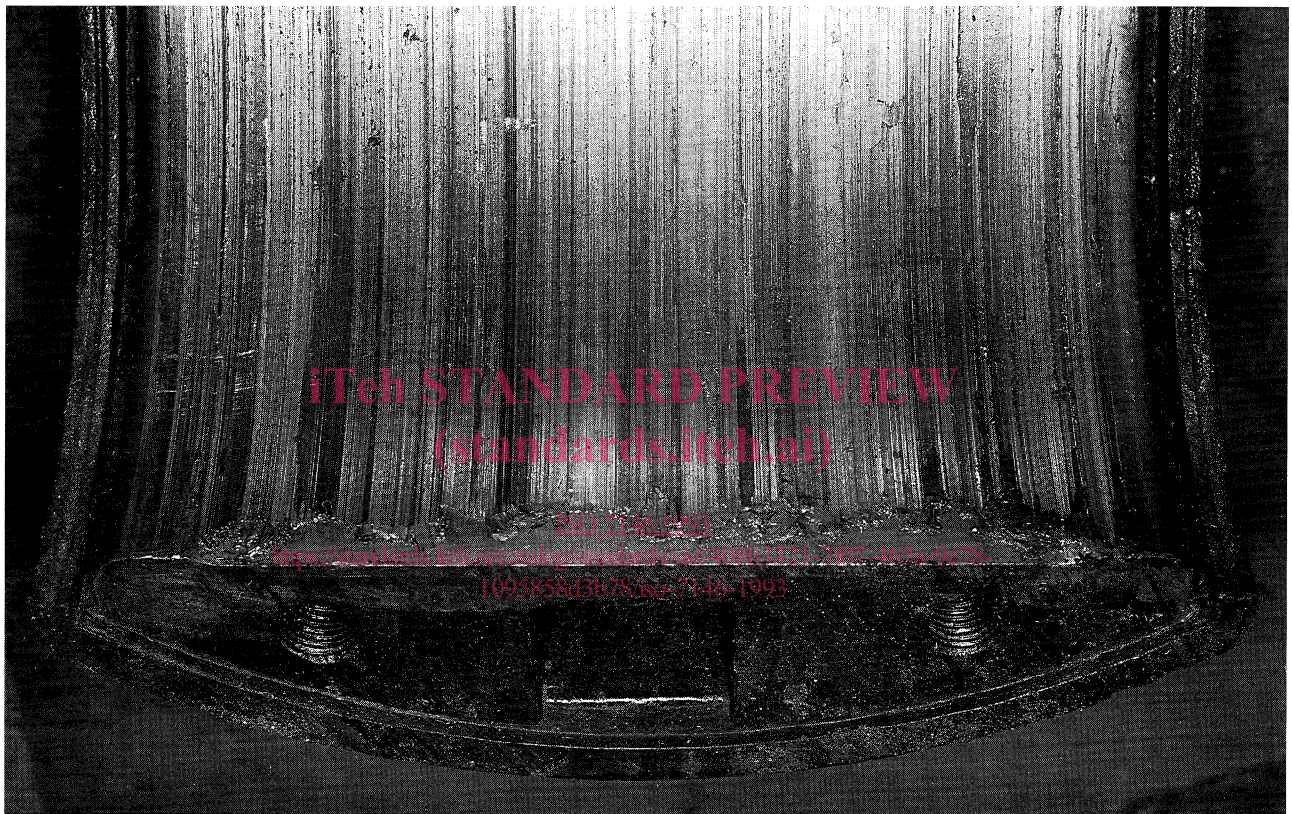
Figure 5 — Scoring by particles entrained in the oil on a thick-walled bearing

Magnification: $\times 1$ (actual size)
