**ISO
7146**

Plain bearings — Terms, characteristics and causes of damage and changes in appearance

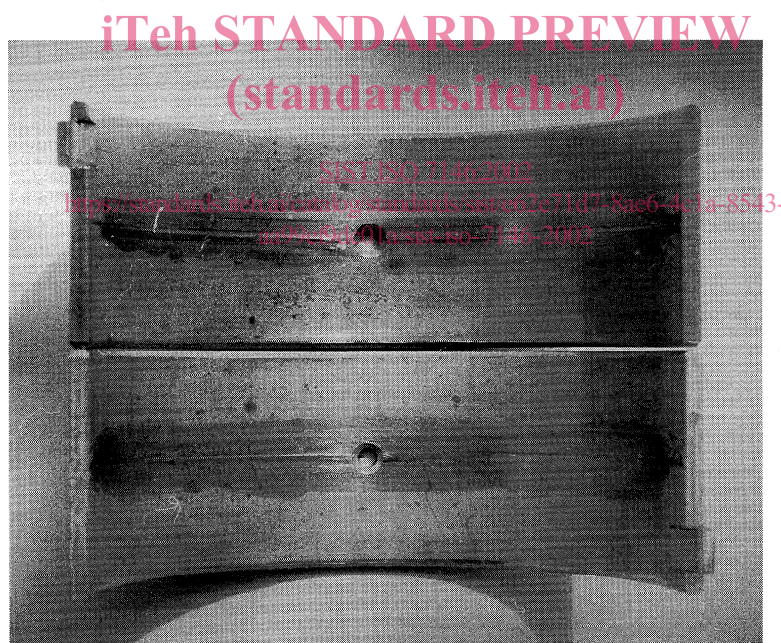
Figure 4 — Deep circumferential score with displaced bearing metal alongside

Material: steel/lead bronze/electroplated overlay
Magnification: x 1 (actual size)

NOTE — Score has been burnished by wear on this thin-walled bearing.

Scratches in the direction of motion. Deep scores or grooves may show displaced bearing metal alongside. Scores and grooves are burnished by wear (see figure 4).

This results in a highly reflective line on both sides of the groove, usually occurring in the most highly loaded region of the bearing, but occasionally around the entire circumference.

Contamination of the oil by large hard particles introduced during manufacture or commissioning (turnings), particles resulting from damage to other components due to poor maintenance, filter damage or bearing damage (fatigue, cavitation wear) to the same bearing or the bearing immediately preceding it in the oil supply system.

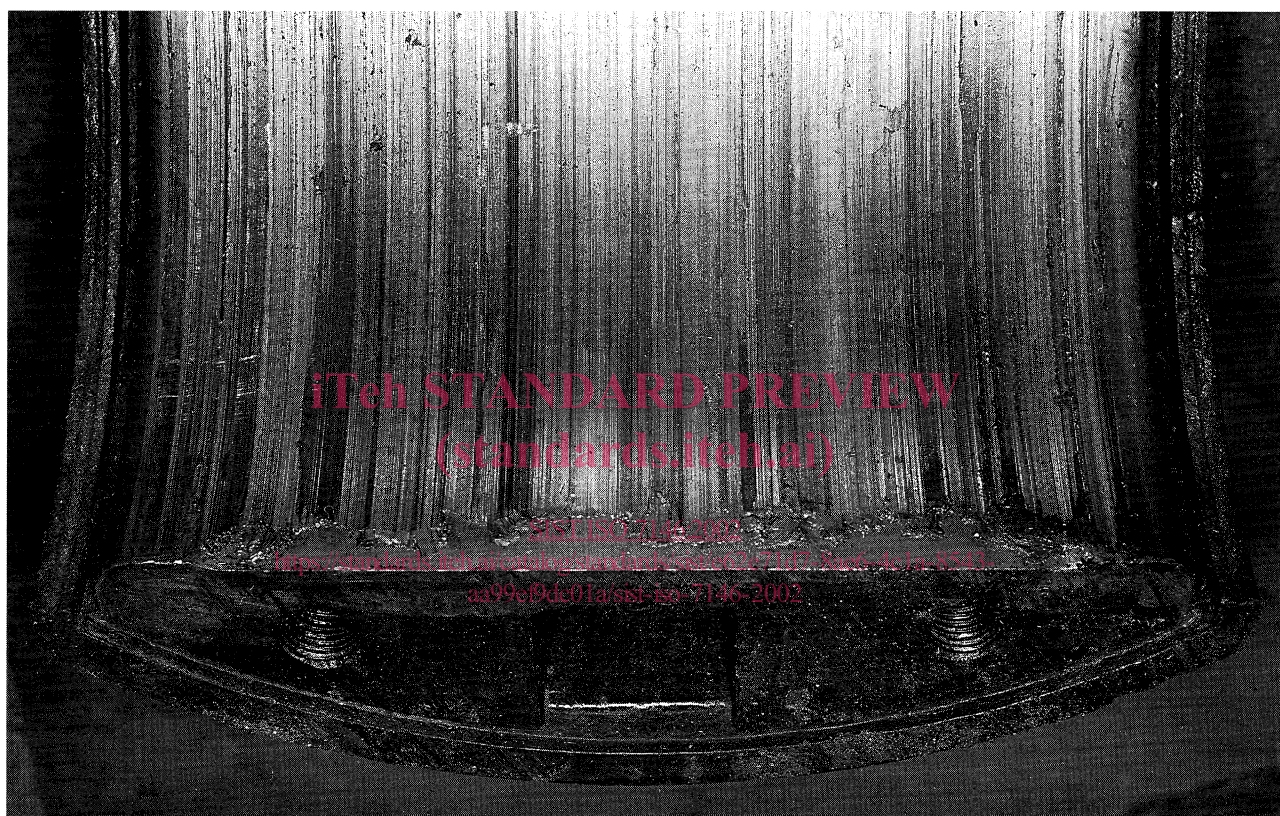
Figure 5 — Scoring by particles entrained in the oil on a thick-walled bearing

Magnification: × 1 (actual size)
