Designation: F 154 – 00

Standard Guide for Identification of Structures and Contaminants Seen on Specular Silicon Surfaces¹

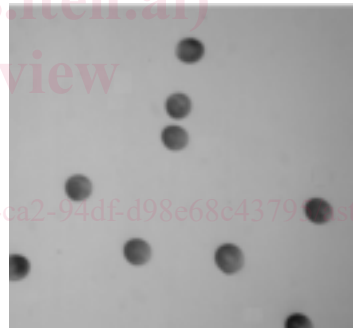
FIG. 5 Dislocation Etch Pits on (100) Silicon Following 5-Min Wright Etch, Magnification 200×.

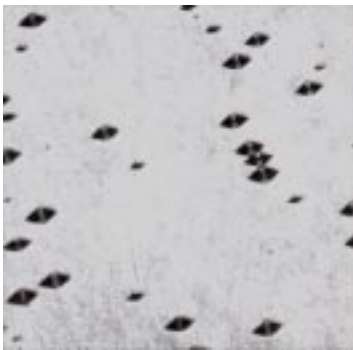
FIG. 2 Dislocation Etch Pits on (110) Silicon, Following 5-Min Wright Etch, Magnification 110×.

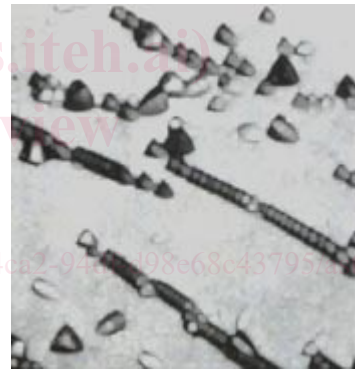
FIG. 11 Lineage on (111) Silicon Following Preferential Etch, Magnification 140 \times .

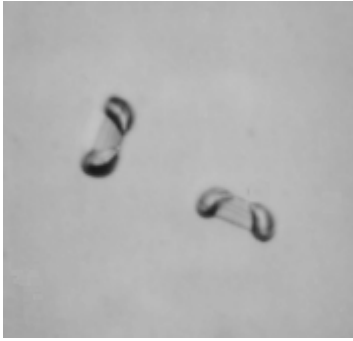
FIG. 12 Oxidation Induced Stacking Faults on (100) Silicon Following Oxidation and 4-min Wright Etch, Magnification 200 \times .

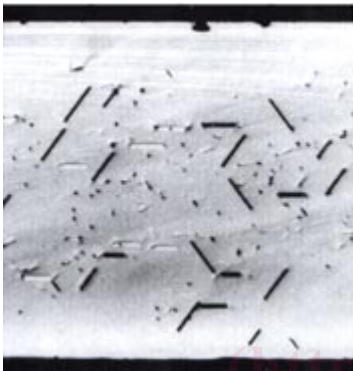
FIG. 19 Oxidation Induced Stacking Faults and Precipitates Found on the Cleavage Face of a Silicon Wafer After Thermal Treatment and 3-Min Secco Etch, Magnification 100 \times .

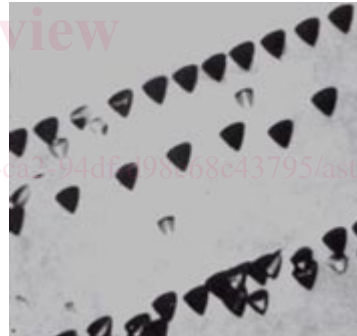
FIG. 23 Slip on a (111) Preferentially Etched Wafer, Magnification 140 \times .

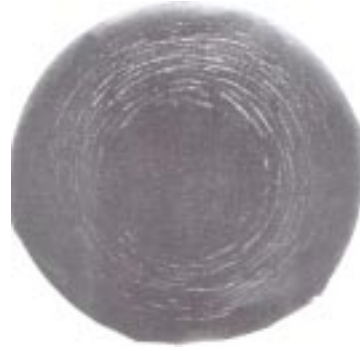
FIG. 27 A-swirl on as Grown Float-Zone Silicon Following Preferential Etch, Full Wafer View.

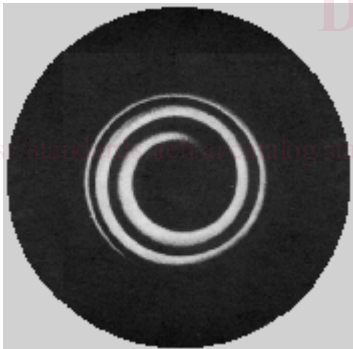
FIG. 26 Swirl Pattern Developed by Preferentially Etching a Czochralski Grown 10 to 20 ohm-cm Lapped Silicon Wafer.

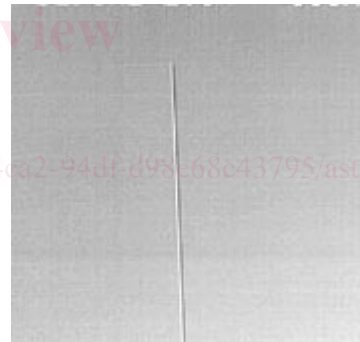
FIG. 29 Twin Line Following 6.5 micron Epitaxial Deposition, No Other Sample Preparation Required, Magnification 300X.
