Annex A

Failure analysis — Illustrations of damage — Terms

ISO 15243:2004 https://standards.iteh.ai/catalog/standards/sist/7221d587-4240-4f51-b79b-2dff5507243b/iso-15243-2004

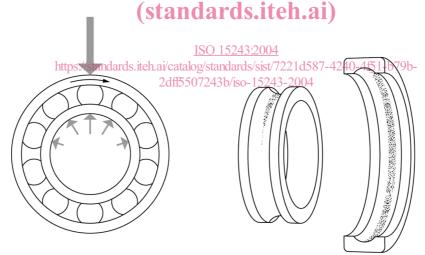
Figure A.2 — Uni-directional radial load — Stationary inner ring – Rotating outer ring

Inner ring: Running path pattern widest in the load direction, tapering towards the ends and positioned in the middle of the raceway. With normal fits and normal internal clearance, the running path pattern extends to less than half of the circumference of the raceway.

Outer ring: Running path pattern uniform in width, positioned in the middle of the raceway and extending around its entire circumference.

Outer ring: Running path pattern uniform in width, wider than in Figure A.2, positioned in the middle of the raceway and extending around its entire circumference.

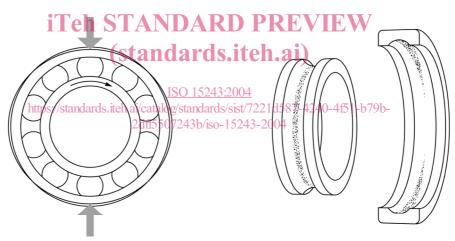
Figure A.8 — Oval compression of outer ring — Rotating inner ring – Stationary outer ring

Inner ring: Running path pattern uniform in width, positioned in the middle of the raceway and extending around its entire circumference.

Outer ring: Running path pattern widest where the compression has occurred and positioned in two diametrically opposed sections of the raceway. The length of the pattern depends upon the magnitude of the compression and the initial radial internal clearance in the bearing.

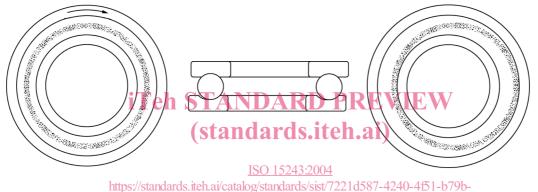
Figure A.10 — Uni-directional axial load on eccentrically positioned housing washer relative to shaft washer — Rotating shaft washer – Stationary housing washer

Shaft washer: Running path pattern uniform in width, wider than in Figure A.9, positioned in the middle of the raceway and extending around its entire circumference.

Housing washer: Running path pattern varying in width, extending around the entire circumference of the raceway and eccentric to the raceway.

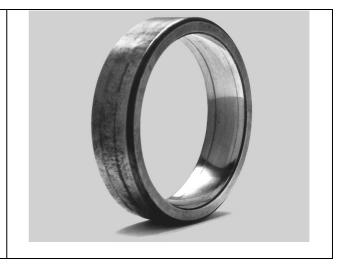
A.2.2.7 Oblique running path flaking pattern on inner ring raceway

Misalignment during operation; shaft deflection; abutment faces on mating part(s) out-of-square. R

Countermeasure Check that the equipment is suitable for the bearing type. Eliminate misalignment or select a bearing type suitable to accommodate the misalignment. Reduce shaft deflection. Check the squareness of the abutment faces on mating part(s).
