Vitreous and porcelain enamels — Glass-lined apparatus for process plants —

Part 5: Presentation and characterisation of defects

Reference number
ISO/FDIS 28721-5:2015(E)

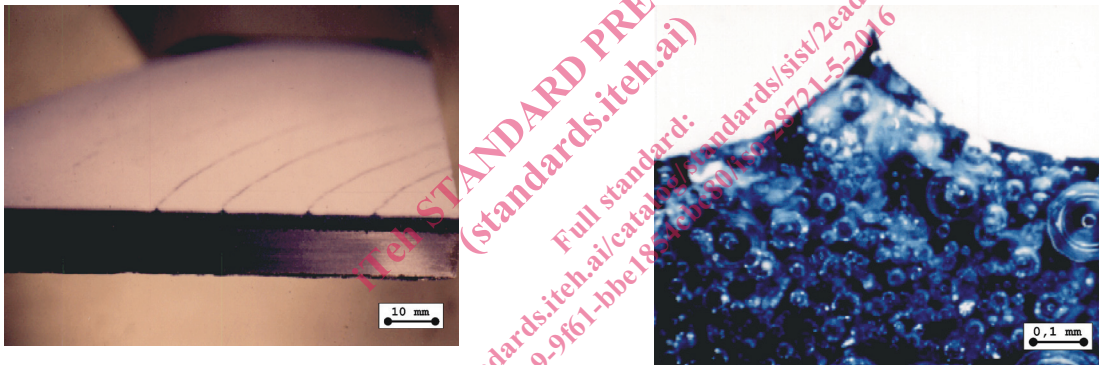
Figure 1 — Strain lines

Strain lines are lines that are always dark and running parallel, or concentrically in the usually blue or white glass cover coat (see Figure 1). In a severe case of strain lines, a number of bubbles or blisters in a single line can appear, forming a pearl line (4.1.4).

a) White cover coat with macroscopically detectable strain lines

b) Lateral view, white cover coat exploring leapt up dark ground coat

Strain lines arise during enamelling due to thermally or mechanically induced stress in the component. When heating up, the ground coat and the covering bisque cracks open. During firing, parts of the ground coat penetrate into the cover coat.

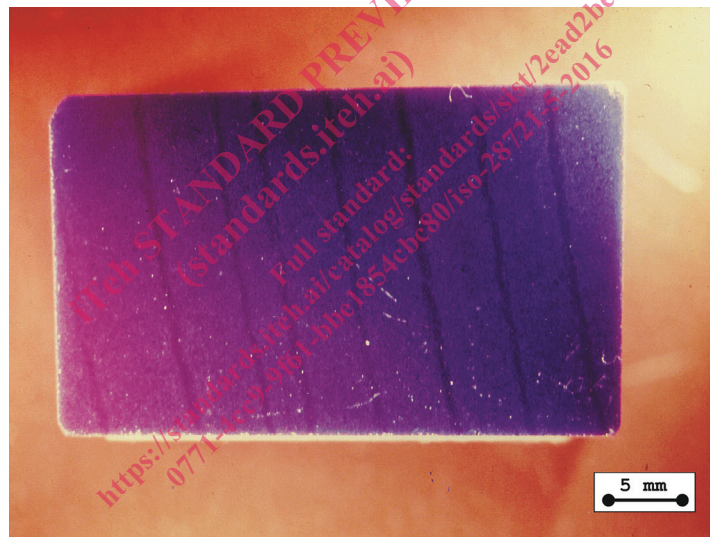
Figure 2 — Tearings

Tearings are mostly dark lines, running parallel or concentrically in the cover coat, i.e. lines that are always dark in blue enamel and either dark or light and transparent in white enamel. In contradiction to pearl lines (see [4.1.4](#)), the lines do not show large blisters and are closely related to strain lines (see [4.1.2](#)). Unlike strain lines, however, these lines are recessed (see [Figure 2](#)).

Tearings arise during enamelling due to thermally or mechanically induced stress in the component. When heating up, the enamel bisque and/or the enamel coating crack(s) open. These cracks merge again during firing. If only the cover coat is affected, dark lines appear. If the crack runs through to the metal surface, blisters in the form of pearl lines also (see [4.1.4](#)) arise along the crack (for causes, see [4.1.2.3](#)).

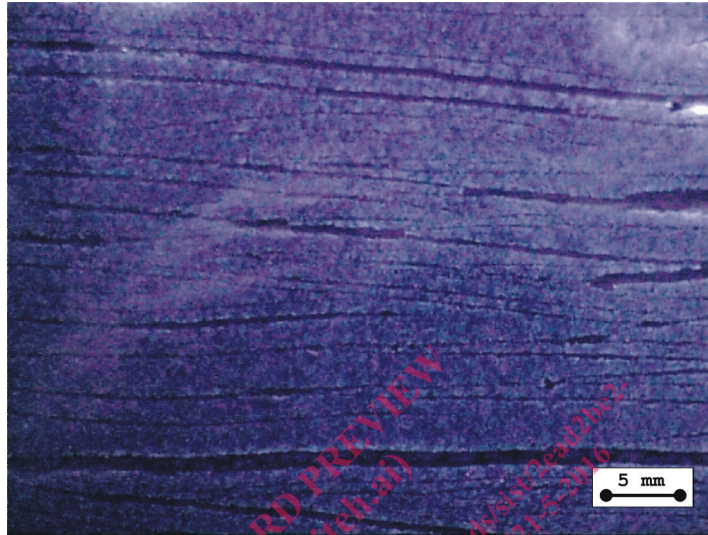
Shore lines are a group of parallel or nearly parallel lines appearing as a deviation in colour (darker in blue enamel and more transparent in white enamel). These lines, that are usually a few millimetres wide and at least one centimetre long, can be positioned anywhere on the enamel surface (see [Figure 4](#)).

Figure 4 — Dark blue shore lines on a blue enamel surface

Following the drying of the bisque, the smaller enamel particles concentrate on the surface and form a thin and lighter-coloured upper layer following enamelling. Therefore, the defects of this layer appear darker. In order to remove dust before firing, the enamel bisque is cleaned by means of a hand broom. If, in doing so, the surface of the bisque is slightly damaged, these scratch marks appear as dark lines following firing.
