**Goriva za motorna vozila - Področja trga dizelskih goriv - Poročilo o raziskavi  
abrazivnih delcev**

Automotive fuels - Diesel fuel market issues - Abrasive particles investigation report

FINAL DRAFT  
FprCEN/TR 17548

Automotive fuels - Diesel fuel market issues - Abrasive  
particles investigation report

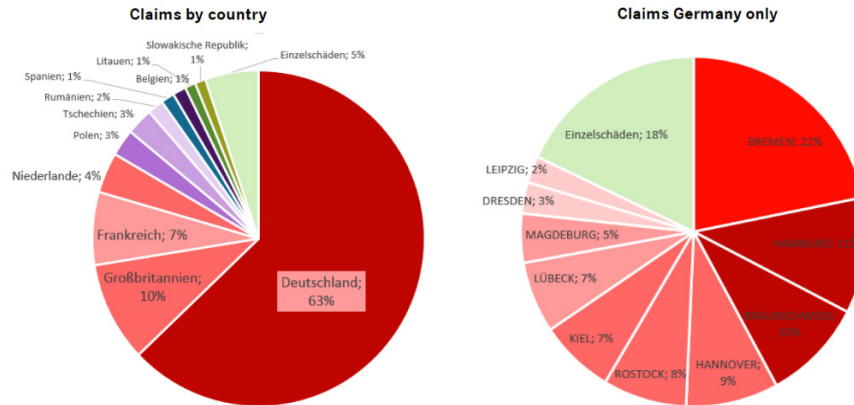
**Figure 1 — Injector complaints inner leakage OM 47x (Courtesy Daimler)**

Build year 2016, repair year 2017, status 08/2017

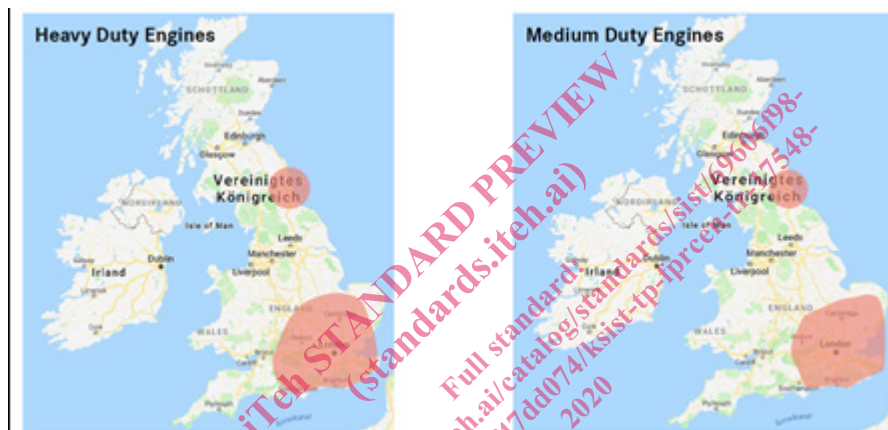
Figure 5 — Injector claims “inner leakage” Great-Britain 2017/2018 (Courtesy Daimler)

NOTE The claim rate in the marked areas is 13 times higher than in other parts of Great Britain.

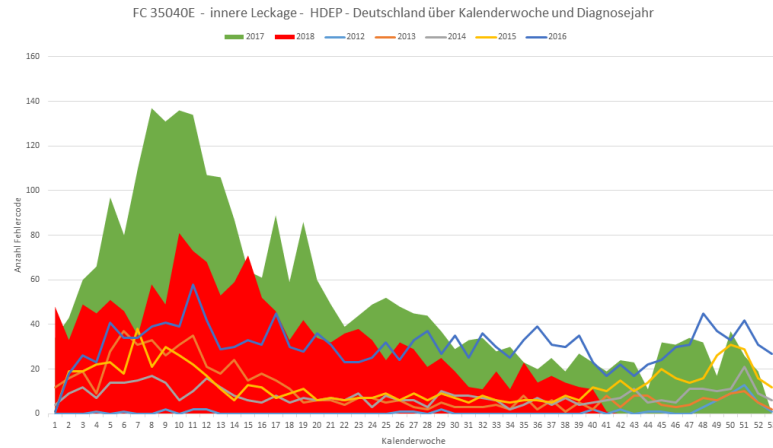
**Figure 7 — Daimler vehicle complaints in Germany (Courtesy Daimler)**

Only certain areas of Europe are affected with the highest numbers of vehicle incidents reported in Northern Germany, the Southeast of the UK followed by Northern France and a small number in Spain. See Figures 1 through 15 for the reports on the incidents. The vehicle manufacturers have reported a small number of failures elsewhere in Europe but these are deemed as isolated incidents. Failures are more common during the winter in the January/March timeframe (see Figure 7 and 10).

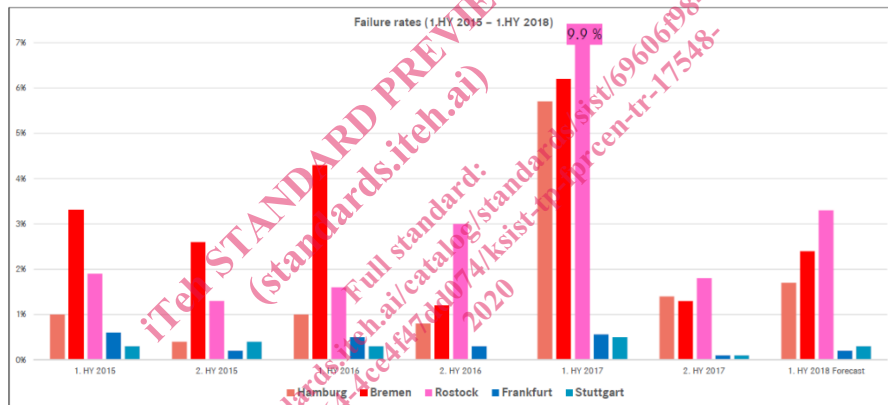
**Figure 8 — Injector failure rates HDEP in Germany (Courtesy Daimler)**

Figure 8 illustrates the difference in injector failure rates between Northern and Southern Germany.

Redish bars Northern Germany

Southern Germany

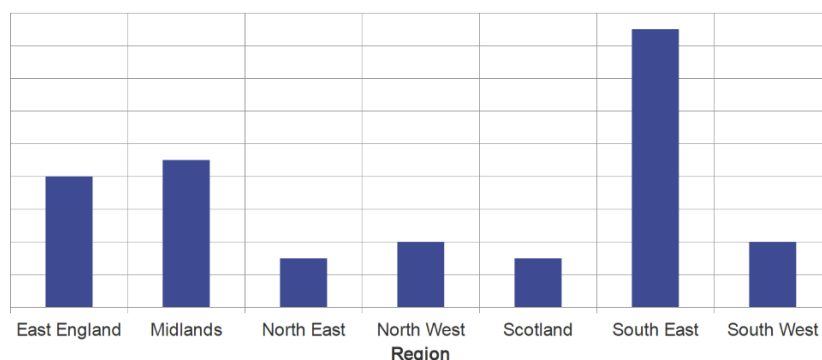
Figure 11 — UK warranty information - Injectors (Courtesy DAF UK)

Figure 11 shows DAF (UK) comparative warranty rates for injectors and highlights the Southeast of the UK area with the highest number of returns. Note that actual numbers are not reported for Figures 11 and 12 due to commercial confidentiality requirements.

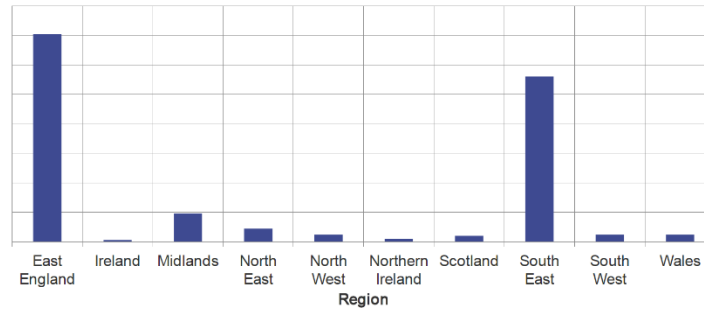
**Figure 12 — UK warranty information – Rail and PRV (Courtesy DAF UK)**

Figure 12 shows comparative warranty information for the Fuel Rail Pressure Regulating Valve (PRV) and highlights that the highest number of failures are in the Southeast and East of England.

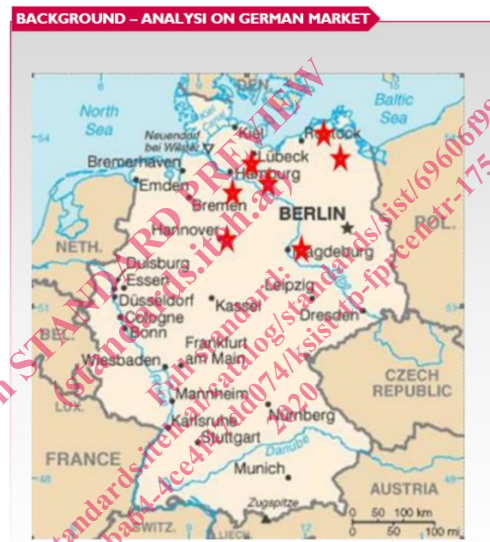
**Figure 13 — CNH Industrial reported incidents (Courtesy CNH Industrial)**

Reported incidents (2014-2017) by CNH Industrial are plotted in Figure 13 and these again are clustered in Northern Germany (at least 25 % of claims are located in that area).
