Designation: F 154 – 02

Standard Guide for Identification of Structures and Contaminants Seen on Specular Silicon Surfaces¹

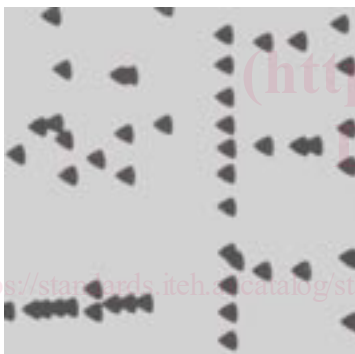
FIG. 1 Dislocation Etch Pits on (111) Silicon, Following 3-Min Sirtl Etch, Magnification 110×.

| Defect | Common Synonyms and Acronyms | Illustrating Figures | Relevant ASTM Standard |
|---|--|---|---|
| Dislocation etch pit | Etch Pit, Pit | 1-5 | F 1725 |

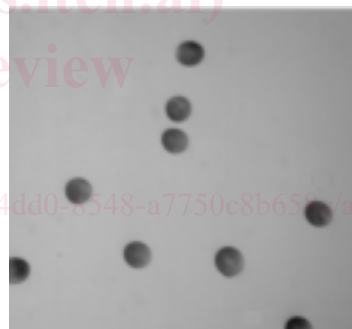
FIG. 5 Dislocation Etch Pits on (100) Silicon Following 5-Min Wright Etch, Magnification 200×.

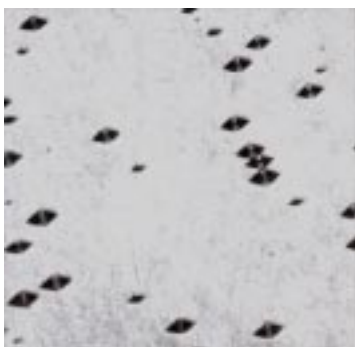
FIG. 2 Dislocation Etch Pits on (110) Silicon, Following 5-Min Wright Etch, Magnification 110×.

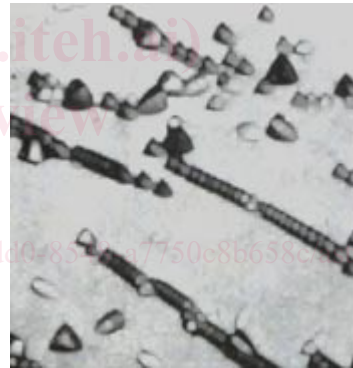
FIG. 11 Lineage on (111) Silicon Following Preferential Etch, Magnification 140 \times .

| Defect | Common Synonyms and Acronyms | Illustrating Figures | Relevant ASTM Standard |
|---|--|---|---|
| Lineage | Grain Boundary | 11 | F 1725 |

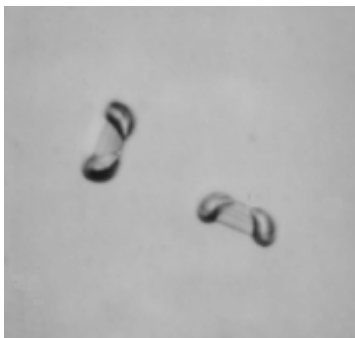
FIG. 12 Oxidation Induced Stacking Faults on (100) Silicon Following Oxidation and 4-min Wright Etch, Magnification 200X.

| Defect | Common Synonyms and Acronyms | Illustrating Figures | Relevant ASTM Standard |
|---|--|---|---|
| Oxidation induced stacking fault | oxidation stacking fault, (OSF), oxidation induced stacking fault (OISF) | 12-18 | F 1727 F 1809 |

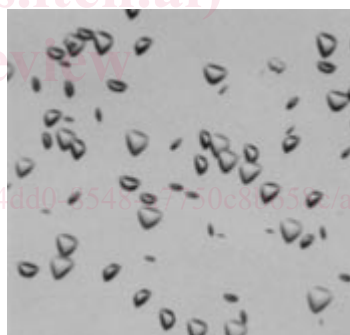
FIG. 17 Oxidation Induced Stacking Faults on (111) Silicon Following Oxidation and 4 Min Wright Etch, Magnification 200X.

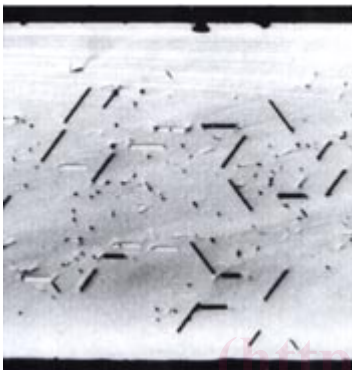
FIG. 19 Oxidation Induced Stacking Faults and Precipitates Found on the Cleavage Face of a Silicon Wafer After Thermal Treatment and 3-Min Secco Etch, Magnification 100 \times .

| Defect | Common Synonyms and Acronyms | Illustrating Figures | Relevant ASTM Standard |
|---|--|---|---|
| Oxide precipitates | bulk micro-defect, (BMD), bulk precipitate | 19 | F 1727 F 1809 |

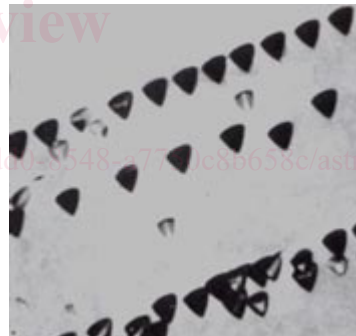
FIG. 23 Slip on a (111) Preferentially Etched Wafer, Magnification 140 \times .

| Defect | Common Synonyms and Acronyms | Illustrating Figures | Relevant ASTM Standard |
|---|--|---|---|
| Slip | Slip Lines | 22-25 | F 1725 F 1727 F 1809 |

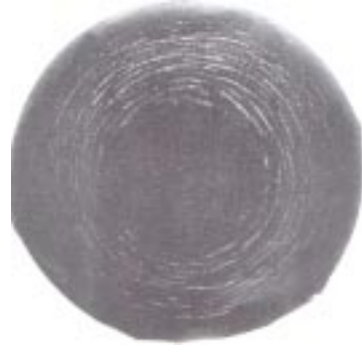
FIG. 27 A-swirl on as Grown Float-Zone Silicon Following Preferential Etch, Full Wafer View.

| Defect | Common Synonyms and Acronyms | Illustrating Figures | Relevant ASTM Standard |
|---|--|---|---|
| Swirl | | 26-27 | F 1725 F 1727 F 1809 |

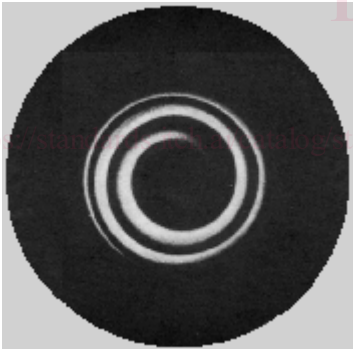
FIG. 26 Swirl Pattern Developed by Preferentially Etching a Czochralski Grown 10 to 20 ohm-cm Lapped Silicon Wafer.

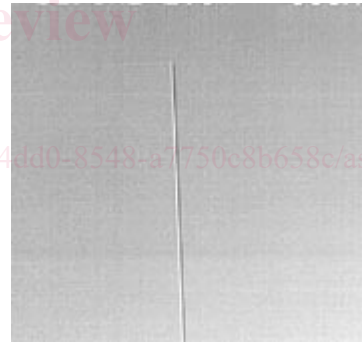
FIG. 29 Twin Line Following 6.5 micron Epitaxial Deposition, No Other Sample Preparation Required, Magnification 300 \times .

| Defect | Common Synonyms and Acronyms | Illustrating Figures | Relevant ASTM Standard |
|---|--|---|---|
| Twin | Twin Lamella Twin Line | 28-30 | F 1725 |
