Designation: F1236 - 18 F1236 - 19

Standard Guide for Visual Inspection of Electrical Protective Rubber Products¹

1.1 The purpose of this guide is to present methods and techniques for the visual inspection of electrical protective rubber products. This guide also includes descriptions and photographs of irregularities found in these products.

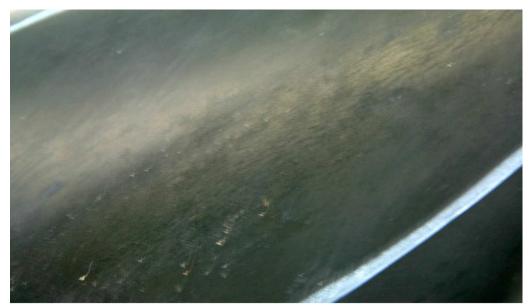
FIG. 3 Age Cracks

3.1.2 *age cracks*—surface cracks that may look like the crazing of glazed ceramics and become progressively worse with time (see Fig. 3).

It is a slow oxidation process caused by exposure to sunlight (or other environmental conditions) and starts in areas of the rubber that are under stress; see 3.1.14 for ozone cracks damage.

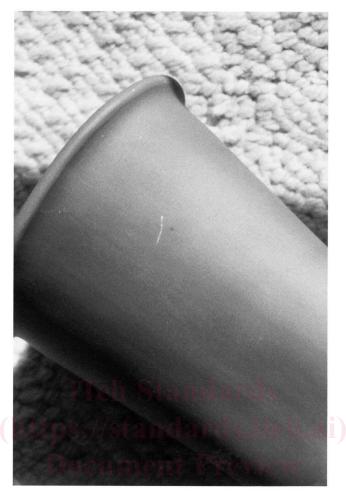
FIG. 8 Color Splash

3.1.5 *color splash*—a spot or blotch on the surface of a rubber product that occurred during the manufacturing process when a contrasting colored particle of unvulcanized rubber became embedded into the finished product (see Fig. 8).

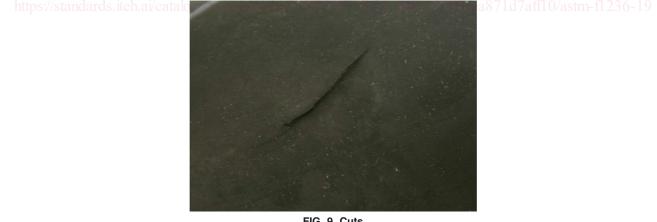
FIG. 9 Cuts

3.1.6 *cuts*—smooth incisions in the surface of the rubber that are usually caused by a sharp-edged object that can increase in size when they are placed under strain (see Fig. 9).

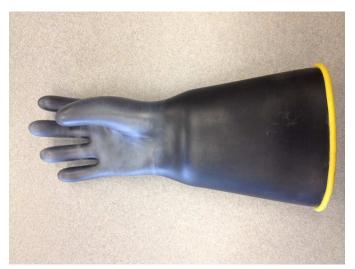
FIG. 13 Glove Discoloration

3.1.10 *glove discoloration*—a non-harmful surface discoloration on a rubber insulating glove caused by the leaching of the tanning chemicals in leather protectors when protectors are left on the rubber insulating glove for an extended time; this is accelerated when the protectors are wet (see Figs. 12-14).
