Designation: ~~F1236—19~~ F1236 – 23

## Standard Guide for Visual Inspection of Electrical Protective Rubber Products<sup>1</sup>

1.1 The purpose of this guide is to present methods and techniques for the visual inspection of electrical protective rubber products. This guide also includes descriptions and photographs of irregularities found in these products.

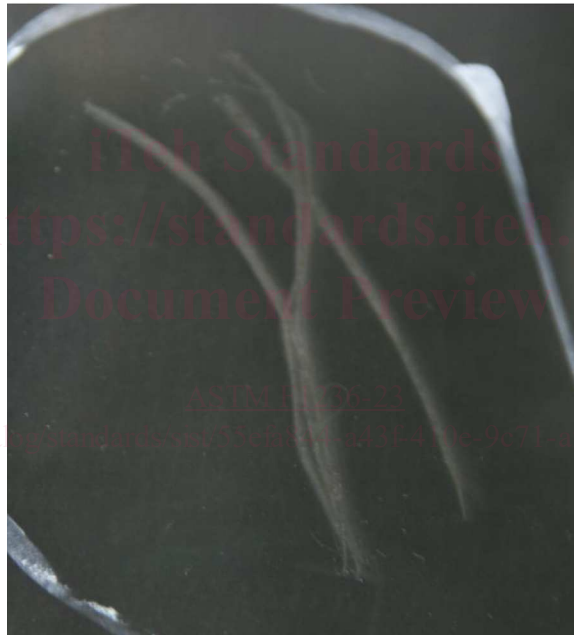
FIG. 2 Scratches

3.1.1 *abrasions and scratches*—surface damage that normally occurs when a product makes contact with an abrasive surface (see Fig. 1 and Fig. 2).

3.1.13 *nicks, snags, or scratches*—angular tears, notches, or chip-like injuries in the surface of the rubber that have been caused by barbed wire, sharp pointed tools, staples, splinters or similar sharp edged hazards (see Fig. 2, Fig. 21, and Fig. 22).

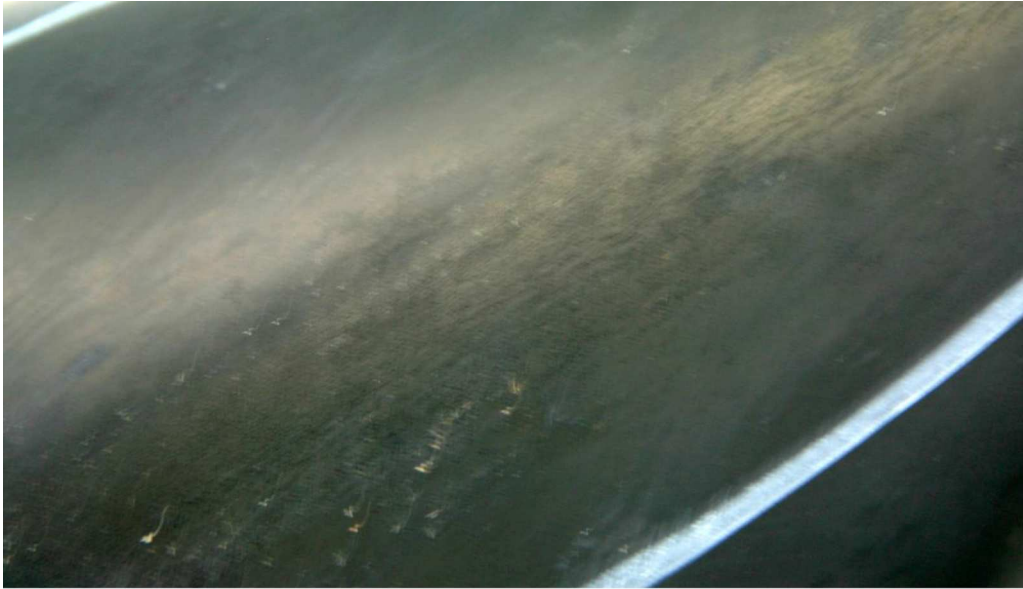
FIG. 3 Age Cracks

3.1.2 *age cracks*—surface cracks that may look like the crazing of glazed ceramics and become progressively worse with time (see Fig. 3).

It is a slow oxidation process caused by exposure to sunlight (or other environmental conditions) and starts in areas of the rubber that are under stress; see 3.1.14 for ozone cracks damage.

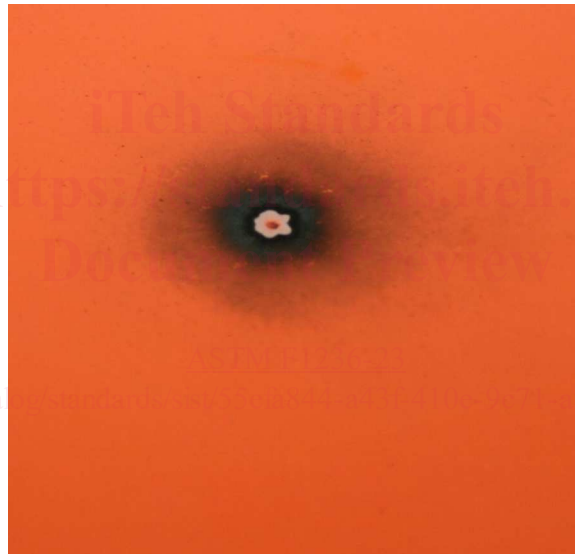
FIG. 4 Breakdown (Dielectric Failure Blanket: Back)

3.1.3 *breakdown*—the electrical discharge or arc occurring between the electrodes and through the equipment being tested (see Figs. 4-6).

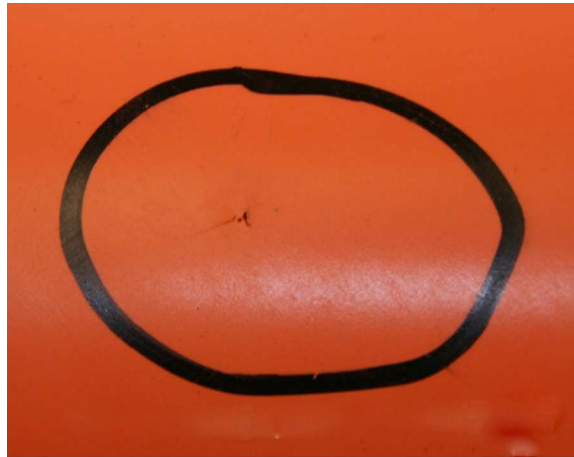
FIG. 5 Breakdown (Dielectric Failure Blanket: Front)

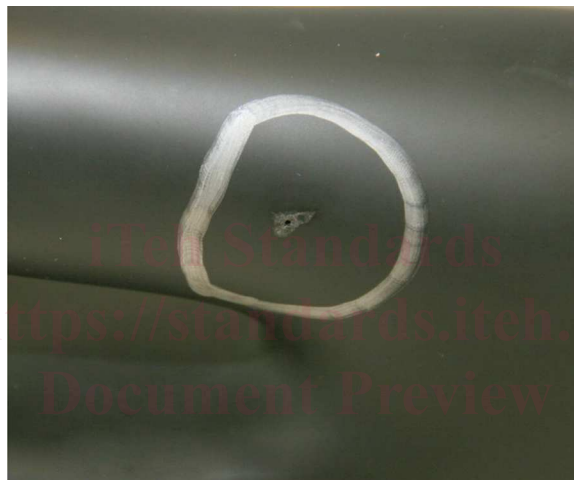
FIG. 6 Breakdown (Dielectric Failure)

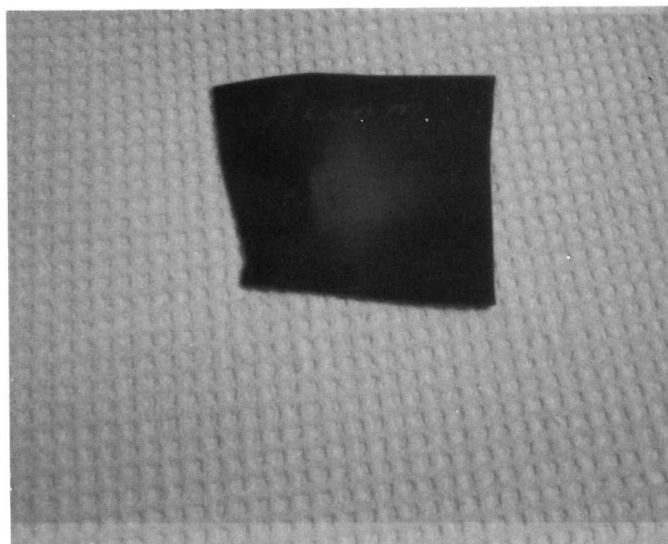
FIG. 7 Chemical Bloom

3.1.4 *chemical bloom*—a white or yellowish discoloration on the surface of a rubber product caused by the migration to the surface of chemical additives used in the manufacturing process of the finished product (see Fig. 7), caused by the natural aging process.

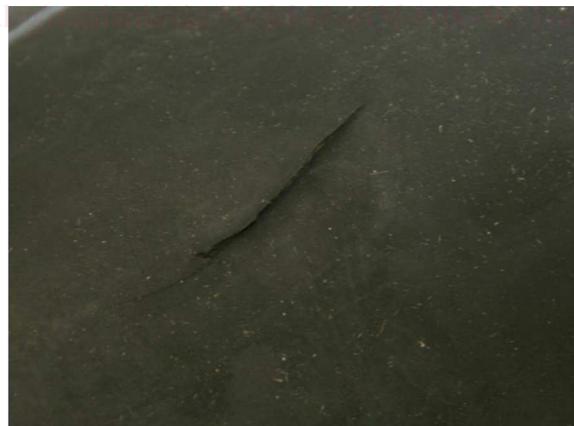
FIG. 9 Cuts

3.1.6 *cuts*—smooth incisions in the surface of the rubber that are usually caused by a sharp-edged object that can increase in size when they are placed under strain (see Fig. 9).

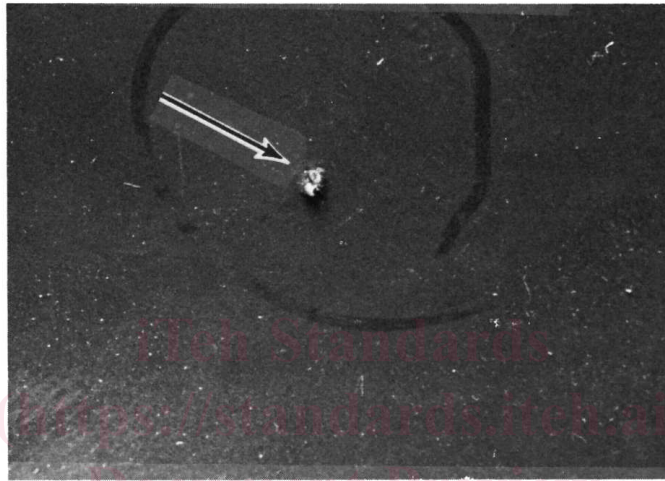
FIG. 11 Foreign Matter

3.1.8 *embedded foreign matter*—a particle of non-rubber material that has been molded into the finished product and may appear as a bump when the rubber is stretched (see Fig. 11).

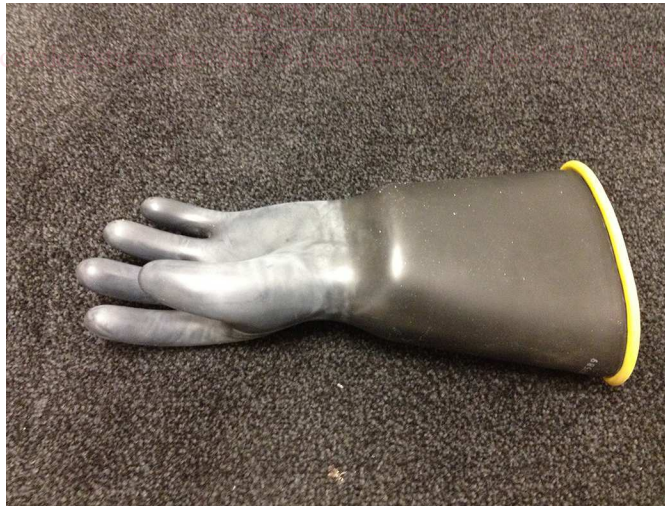
FIG. 12 Glove Discoloration

3.1.10 *glove discoloration*—a non-harmful surface discoloration on a rubber insulating glove caused by the leaching of the tanning chemicals in leather protectors when protectors are left on the rubber insulating glove for an extended time; this is accelerated when the protectors are wet (see Figs. 12-14).

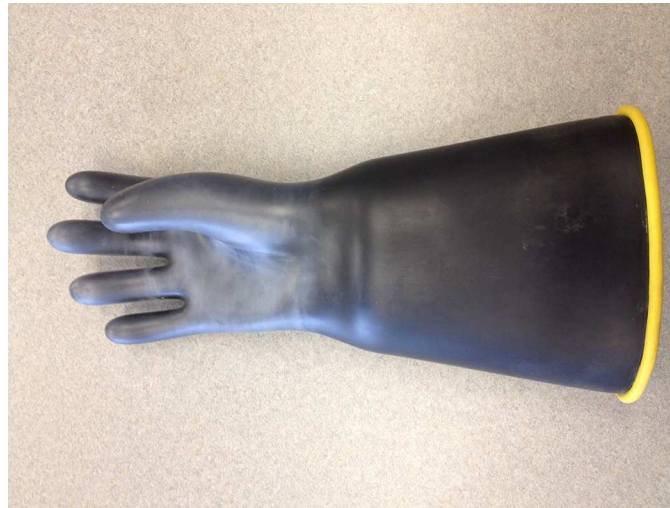
FIG. 13 Glove Discoloration

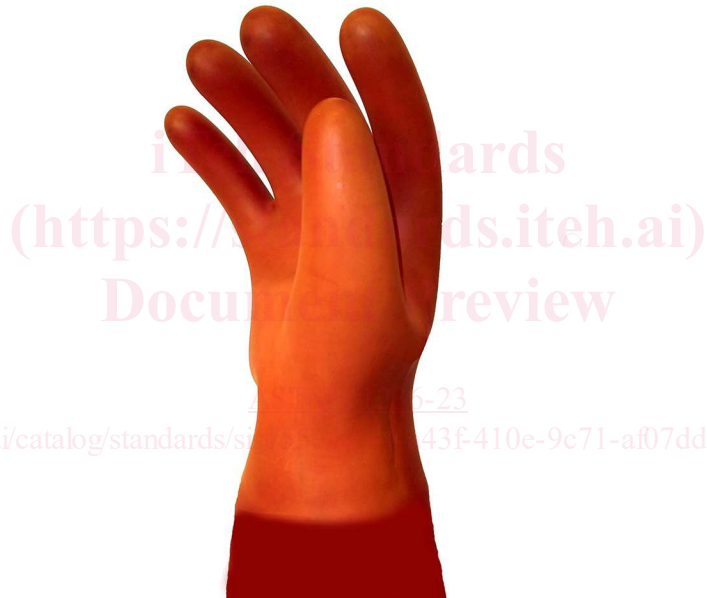
FIG. 14 Glove Discoloration

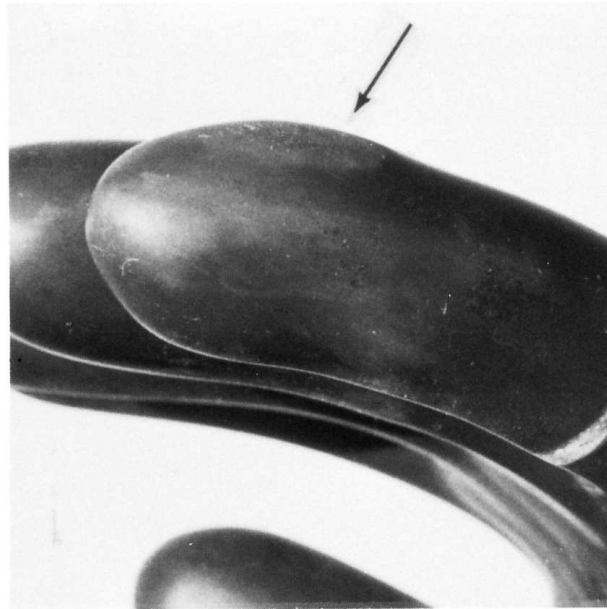
FIG. 15 Hard Spot

3.1.11 *hard spot*—a hardened area on the rubber surface that is usually caused by exposure to high heat or chemical attack (see Figs. 15-18).

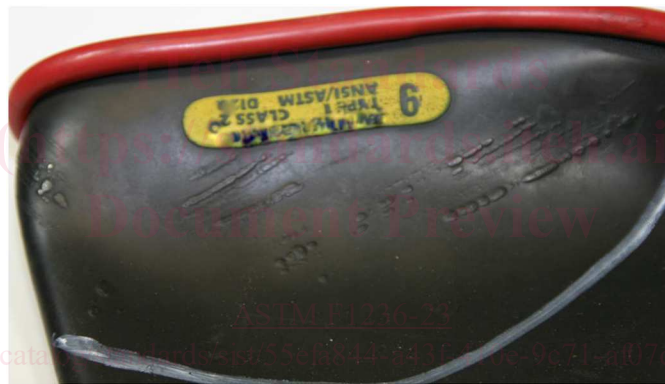
FIG. 16 Hard Spot

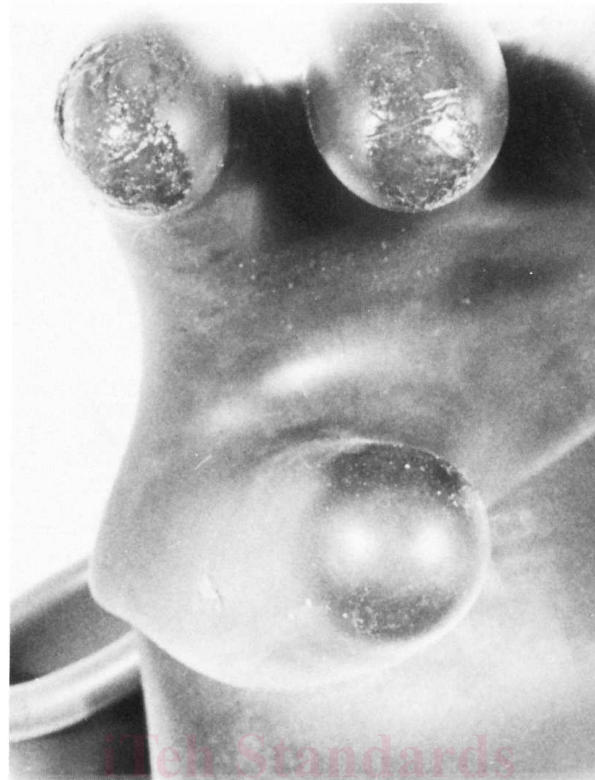
FIG. 17 Hard Spot

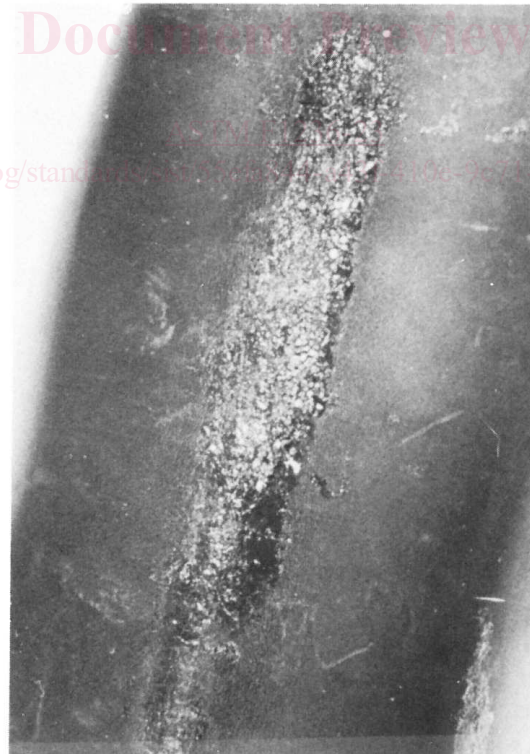
FIG. 18 Hard Spot

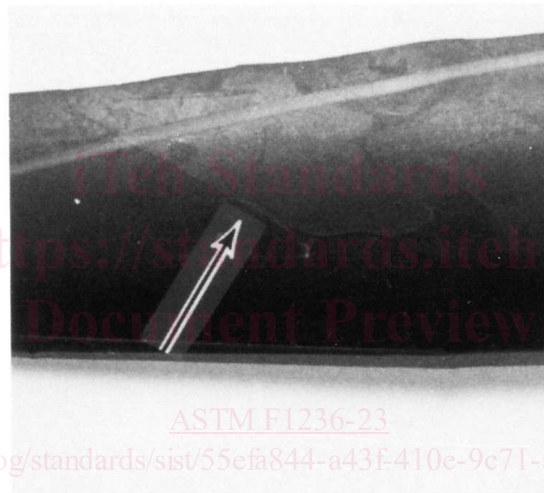
FIG. 20 Mold Marks

3.1.12 *mold marks*—a raised or indented section on the surface of the rubber that was caused by an irregularity in the mold (see Fig. 19 and Fig. 20).

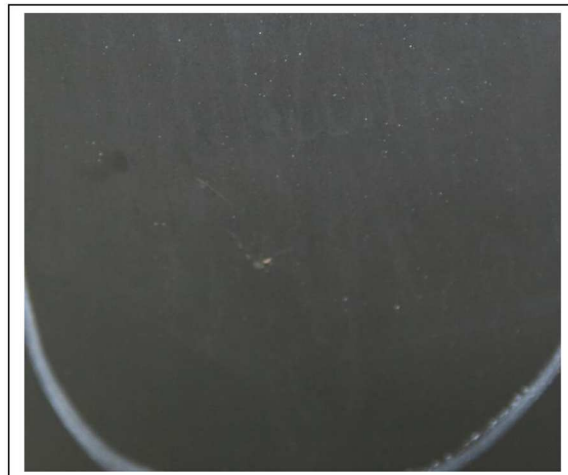
FIG. 21 Nick

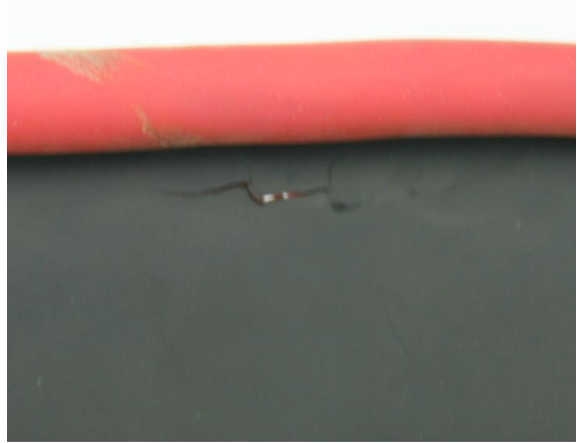
FIG. 22 Snag

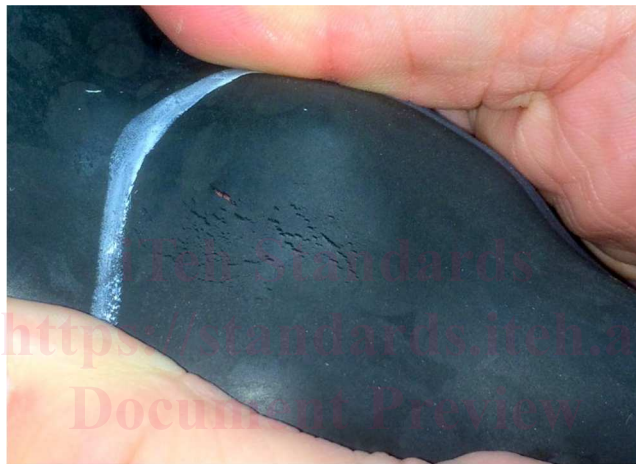
FIG. 23 Ozone Cracks

3.1.14 *ozone cracks*—a series of interlacing cracks that may start at stress points and quickly worsen as a result of rapid oxidation in a highly concentrated ozone atmosphere usually produced by electrical arcing (see Figs. 23-26).

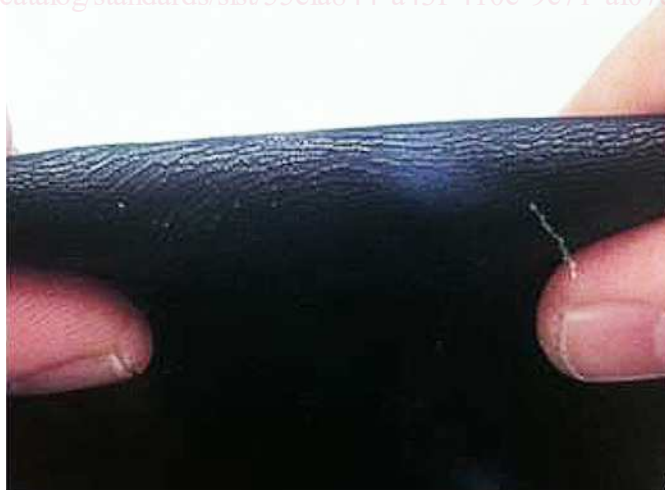
FIG. 24 Ozone Cracks
