INTERNATIONAL STANDARD

Plain bearings — Appearance and characterization of damage to metallic hydrodynamic bearings —

Part 1: General

Reference number ISO 7146-1:2008(E)

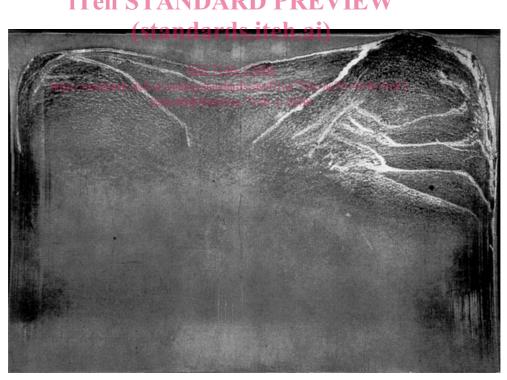
Figure 3 — Creep deformation, shown by crack-free semicircular bulges in the direction of rotation (material: steel/tin-based white metal)

Creep deformation: shallow depressions of bearing material in the region of maximum load and temperature, beginning smooth and ending in crack-free semicircular bulges in the direction of rotation, sometimes like crests of waves (see Figure 3).

Loading of the bearing was higher than that allowed for in the design and/or the bearing temperature was higher than estimated for an extended period.

6.2.3 Typical examples (see Figures 3 and 4)

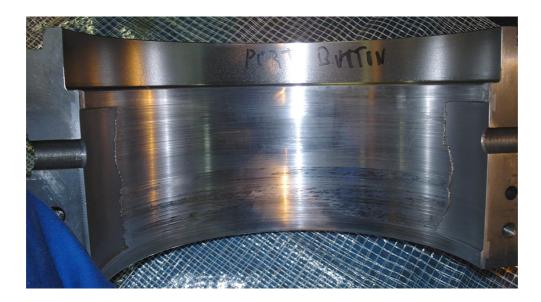
Figure 4 — Propeller shaft bearing, showing the effects of too slow a speed in relation to load capacity (material: steel/tin-based white metal)

Traces of mixed lubrication (see Figure 4), depositions, thermal cracks.
