# INTERNATIONAL STANDARD

# Vitreous and porcelain enamels — Glass-lined apparatus for process plants —

Part 5:

Presentation and characterization of defects

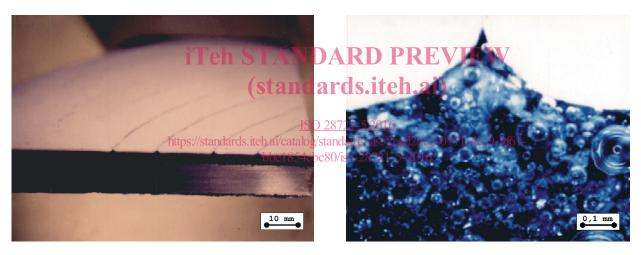
#### Figure 1 — Strain lines

Strain lines are lines that are always dark and running parallel, or concentrically in the usually blue or white glass cover coat (see Figure 1). In a severe case of strain lines, a number of bubbles or blisters in a single line can appear, forming a pearl line (4.1.4).

a) White cover coat with macroscopically detectable strain lines

b) Lateral view, white cover coat exploring leapt up dark ground coat

Strain lines arise during enamelling due to thermally or mechanically induced stress in the component. When heating up, the ground coat and the covering bisque cracks open. During firing, parts of the ground coat penetrate into the cover coat.

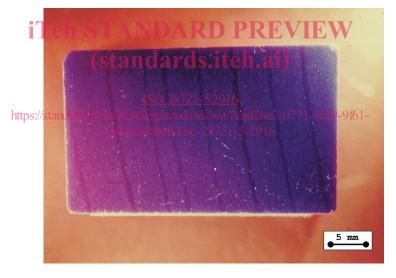
Figure 2 — Tearings

Tearings are mostly dark lines, running parallel or concentrically in the cover coat, i.e. lines that are always dark in blue enamel and either dark or light and transparent in white enamel. In contradiction to pearl lines (see <u>4.1.4</u>), the lines do not show large blisters and are closely related to strain lines (see <u>4.1.2</u>). Unlike strain lines, however, these lines are recessed (see <u>Figure 2</u>).

Tearings arise during enamelling due to thermally or mechanically induced stress in the component. When heating up, the enamel bisque and/or the enamel coating crack(s) open. These cracks merge again during firing. If only the cover coat is affected, dark lines appear. If the crack runs through to the metal surface, blisters in the form of pearl lines also (see <u>4.1.4</u>) arise along the crack (for causes, see <u>4.1.2.3</u>).

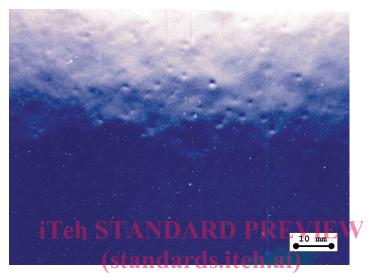
Pearl lines are blisters lying behind each other in a line, often combined with strain lines (see 4.1.1) or tearings (see 4.1.2 and Figure 3).

#### Figure 3 — Pearl lines, i.e. series of blisters in line, in zones showing strain lines (see 4.1.2)

Pearl lines arise during enamelling due to thermally or mechanically induced restraints in the component. When heating up, the enamel bisque and the enamel coating crack open through to the steel. During firing, the metal oxidizes, a process accompanied by gas-forming reactions in the boundary layer. The lines run to form strain lines (see 4.1.2), along which blisters and pores are positioned as if on a string of beads (for causes, see 4.1.2.3).

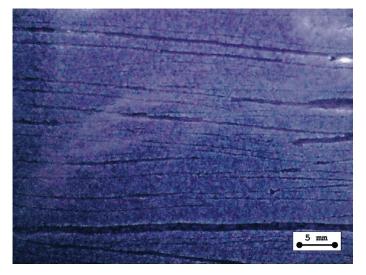
Shore lines are a group of parallel or nearly parallel lines appearing as a deviation in colour (darker in blue enamel and more transparent in white enamel). These lines, that are usually a few millimetres wide and at least one centimetre long, can be positioned anywhere on the enamel surface (see Figure 4).

Shore lines are usually wider than strain lines (see <u>4.1.2</u>), due to a greater width and irregular edges in the longitudinal direction.

Figure 4 — Dark blue shore lines on a blue enamel surface

Following the drying of the bisque, the smaller enamel particles concentrate on the surface and form a thin and lighter-coloured upper layer following enameling. Therefore, the defects of this layer appear darker. In order to remove dust before firing, the enamel bisque is cleaned by means of a hand broom. If, in doing so, the surface of the bisque is slightly damaged, these scratch marks appear as dark lines following firing.
