## Designation: **F1236 – 96 (Reapproved 2012) F1236 – 14**

# Standard Guide for Visual Inspection of Electrical Protective Rubber Products<sup>1</sup>

1.1 The purpose of this guide is to present methods and techniques for the visual inspection of electrical protective rubber products. This guide also includes descriptions and photographs of irregularities found in these products.

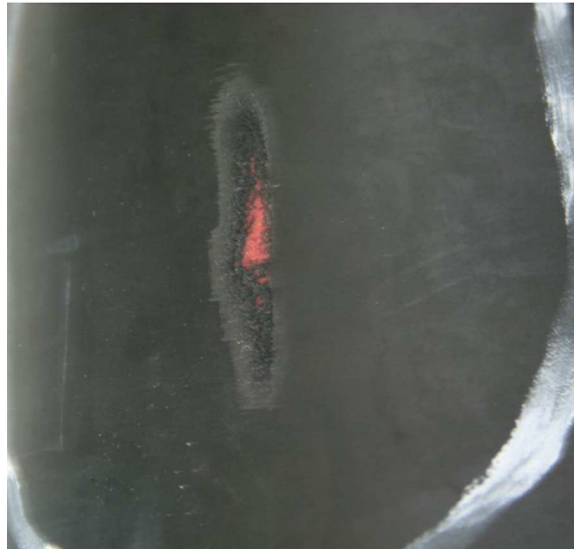
FIG. 1 Abrasion

3.1.1 *abrasions and scratches*—surface damage that normally occurs when a product makes contact with an abrasive surface (see Fig. 1 and Fig. 2).

Scuff-like damage can also occur from a brush contact with a hot object such as a soldering iron. This can sometimes look like the graining on leather.

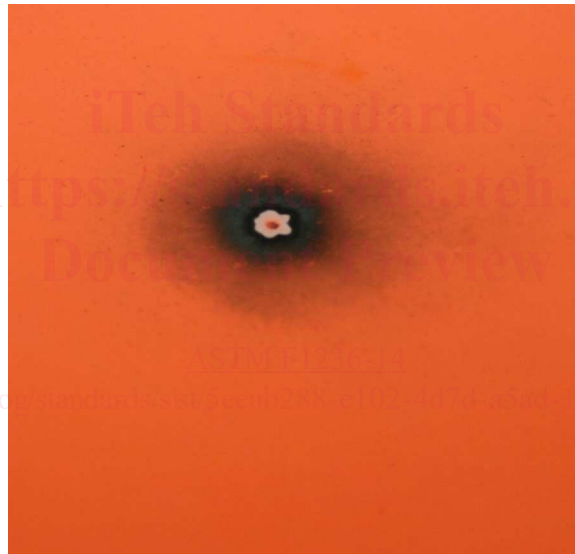
FIG. 4 Breakdown (Dielectric Failure) Failure Blanket: Back

3.1.3 *breakdown*—the electrical discharge or arc occurring between the electrodes and through the equipment being tested (see Fig. 4, Fig. 5 and Fig. 6).

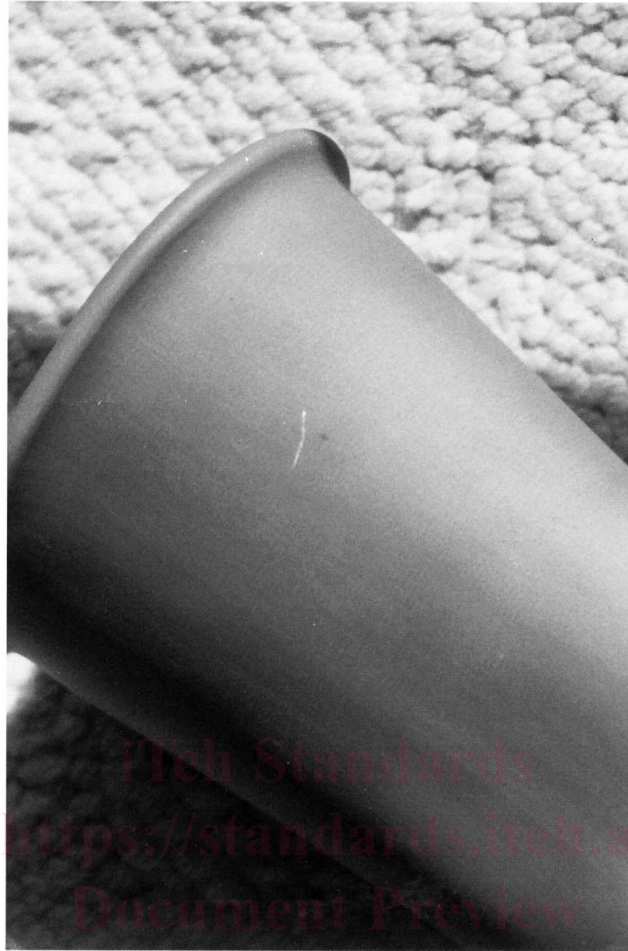
FIG. 68 Color Splash

3.1.5 *color splash*—a spot or blotch on the surface of a rubber product that occurred during the manufacturing process when a contrasting colored particle of unvulcanized rubber became embedded into the finished product (see Fig. 68).

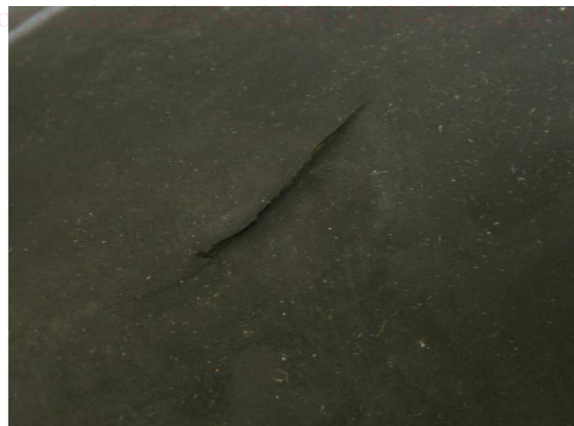
FIG. 79 Cuts

3.1.6 *cuts*—smooth incisions in the surface of the rubber that are usually caused by a sharp-edged object that can increase in size when they are placed under strain (see Fig. 79).

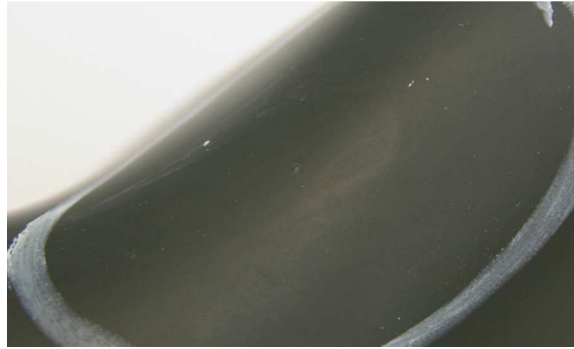
FIG. 810 Depressions or Indentations

3.1.7 *depressions or indentations*—*indentations*—a shallow recess in the surface of the rubber that exhibits a thinner rubber thickness at the bottom of the depression than in the surrounding areas (see Fig. 810).
