Designation: **F1236–15 F1236 – 16**

Standard Guide for Visual Inspection of Electrical Protective Rubber Products¹

1.1 The purpose of this guide is to present methods and techniques for the visual inspection of electrical protective rubber products. This guide also includes descriptions and photographs of irregularities found in these products.

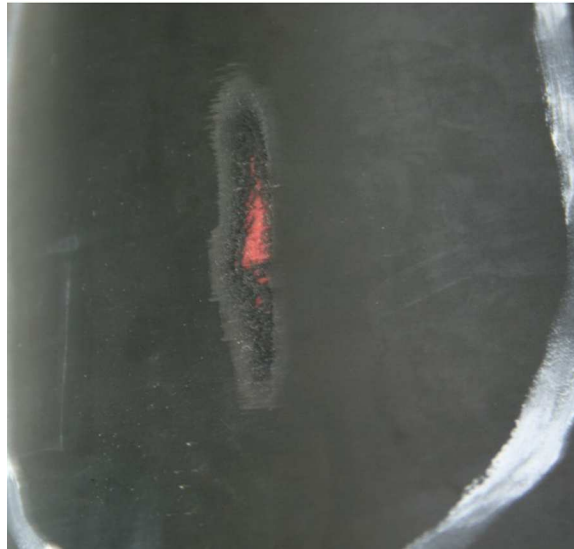
FIG. 1 Abrasion

3.1.1 *abrasions and scratches*—surface damage that normally occurs when a product makes contact with an abrasive surface (see Fig. 1 and Fig. 2).

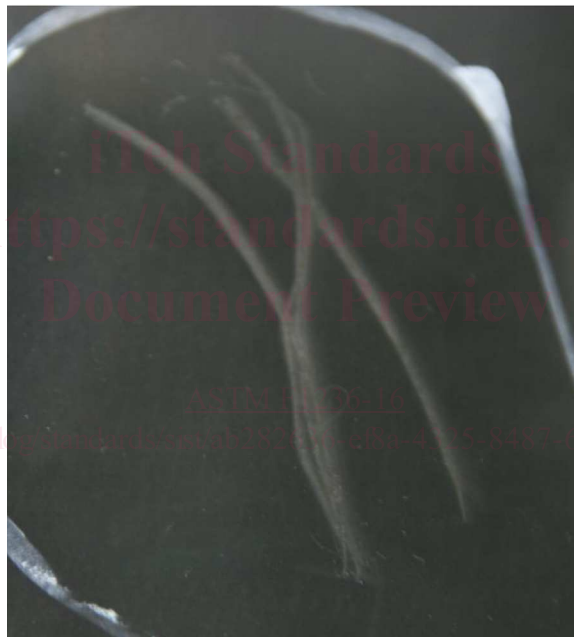
FIG. 2 Scratches

3.1.13 *nicks, snags, or scratches*—angular tears, notches, or chip-like injuries in the surface of the rubber that have been caused by barbed wire, sharp pointed tools, staples, splinters or similar sharp edged hazards (see Fig. 2, Fig. 18, and Fig. 19).

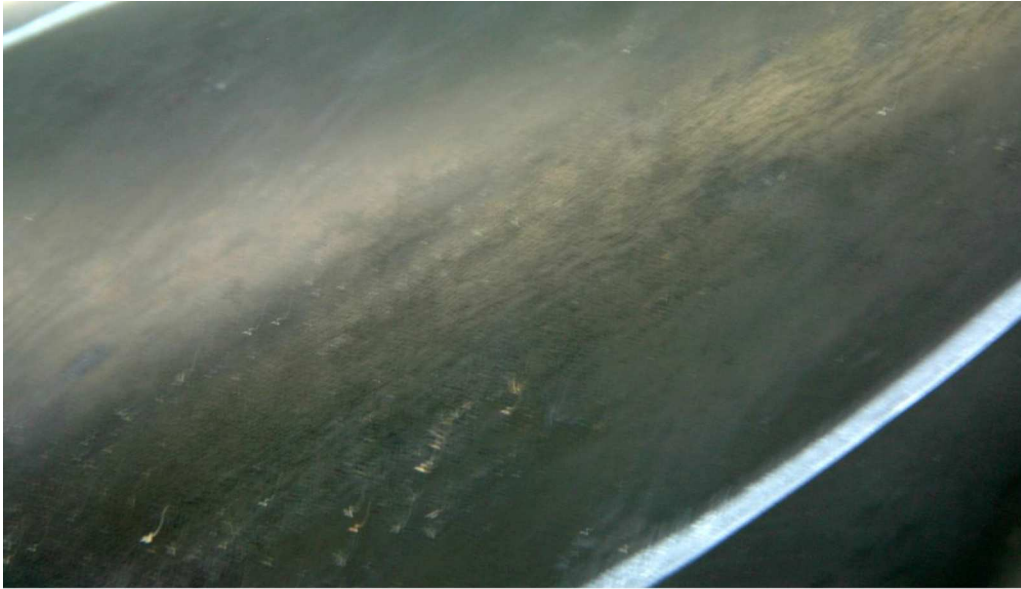
FIG. 3 Age Cracks

3.1.2 *age cracks*—surface cracks that may look like the crazing of glazed ceramics and become progressively worse with time (see Fig. 3).

It is normally a slow oxidation process caused by exposure to sunlight and ozone in the atmosphere and starts in areas of the rubber that are under stress.

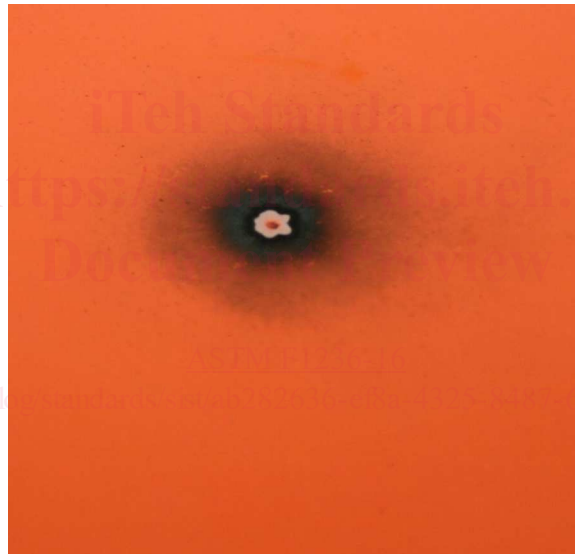
FIG. 4 Breakdown (Dielectric Failure Blanket: Back)

3.1.3 *breakdown*—the electrical discharge or arc occurring between the electrodes and through the equipment being tested (see Fig. 4, Fig. 5 and Fig. 6).

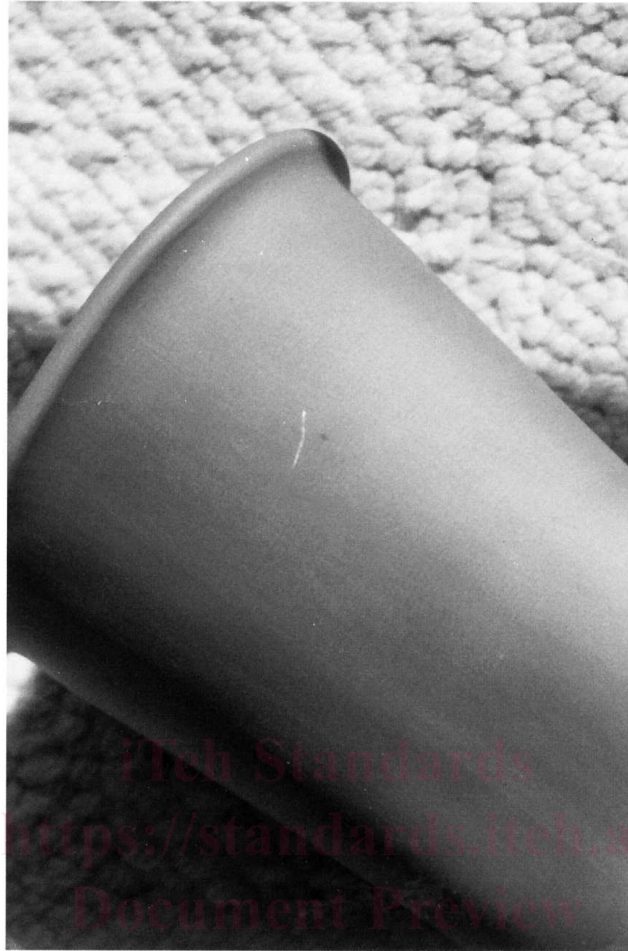
FIG. 8 Color Splash

3.1.5 *color splash*—a spot or blotch on the surface of a rubber product that occurred during the manufacturing process when a contrasting colored particle of unvulcanized rubber became embedded into the finished product (see Fig. 8).

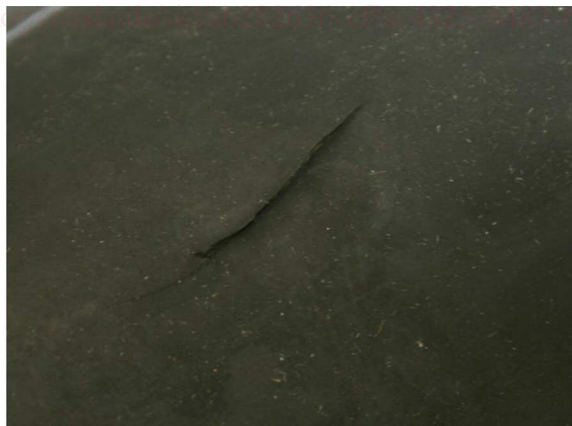
FIG. 9 Cuts

3.1.6 *cuts*—smooth incisions in the surface of the rubber that are usually caused by a sharp-edged object that can increase in size when they are placed under strain (see Fig. 9).

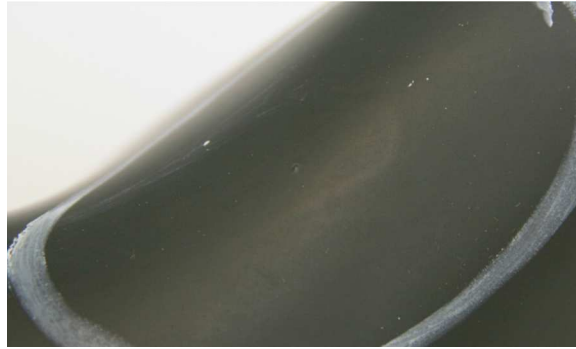
FIG. 10 Depressions

3.1.7 *depressions or indentations*—a shallow recess in the surface of the rubber that exhibits a thinner rubber thickness at the bottom of the depression than in the surrounding areas (see Fig. 10).

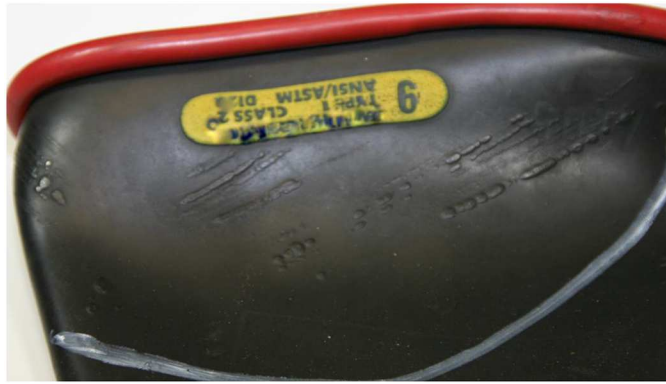
FIG. 1416 Hard Spot

3.1.12 *hard spot*—a hardened area on the rubber surface that is usually caused by exposure to high heat or chemical attack (see Figs. 15-18).

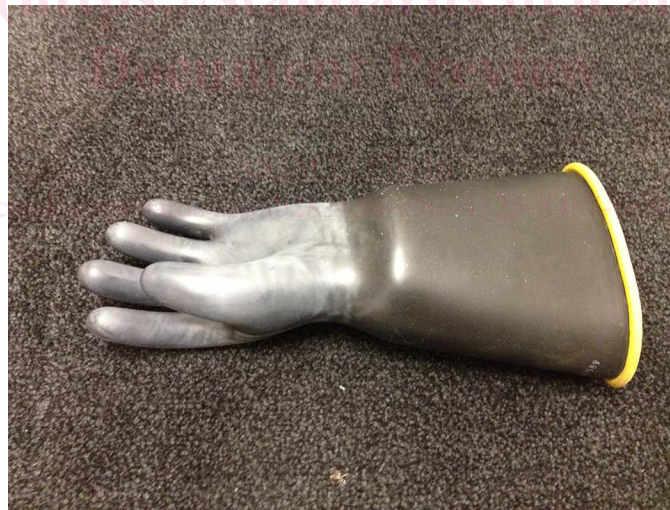
FIG. 12 Glove Discoloration

3.1.11 *glove discoloration*—a non-harmful surface discoloration on a rubber insulating glove caused by the leaching of the tanning chemicals in leather protectors when protectors are left on the rubber insulating glove for an extended time; this is accelerated when the protectors are wet (see Figs. 12-14).

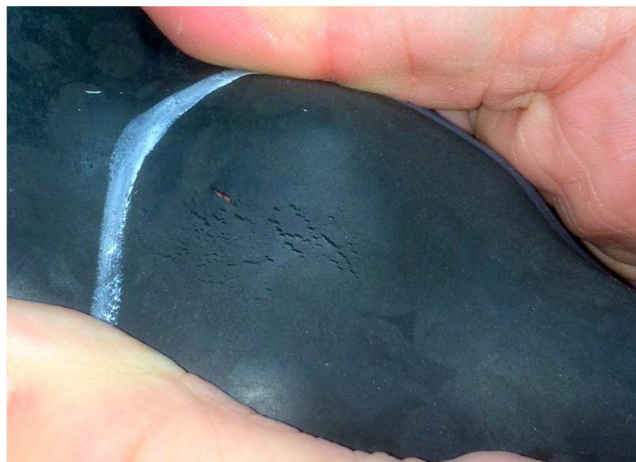
FIG. 2023 Ozone Cracking

3.1.15 *ozone cracks*—a series of interlacing cracks that may start at stress points and quickly worsen as a result of rapid oxidation in a highly concentrated ozone atmosphere usually produced by electrical arcing (see Fig. 23 and Fig. 24).
