Designation: E 433 – 71 (Reapproved 2003)

Standard Reference Photographs for Liquid Penetrant Inspection¹

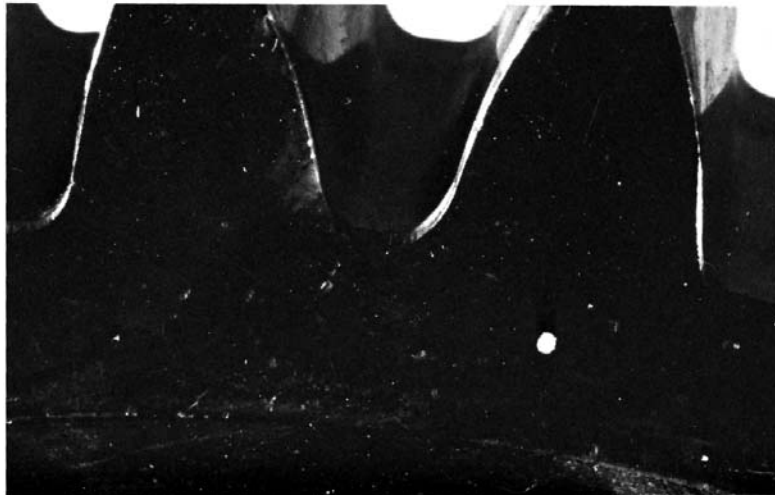
FIG. 1 Example of Type I, Class A, Indication

3.1.1 *Type I Indications*—Those in which neither of the measurable dimensions is greater than three times the other.

- A. Single
- B. Multiple unaligned
- C. Multiple aligned
- D. Intersection of surfaces (threads, corners, fillets, etc.)

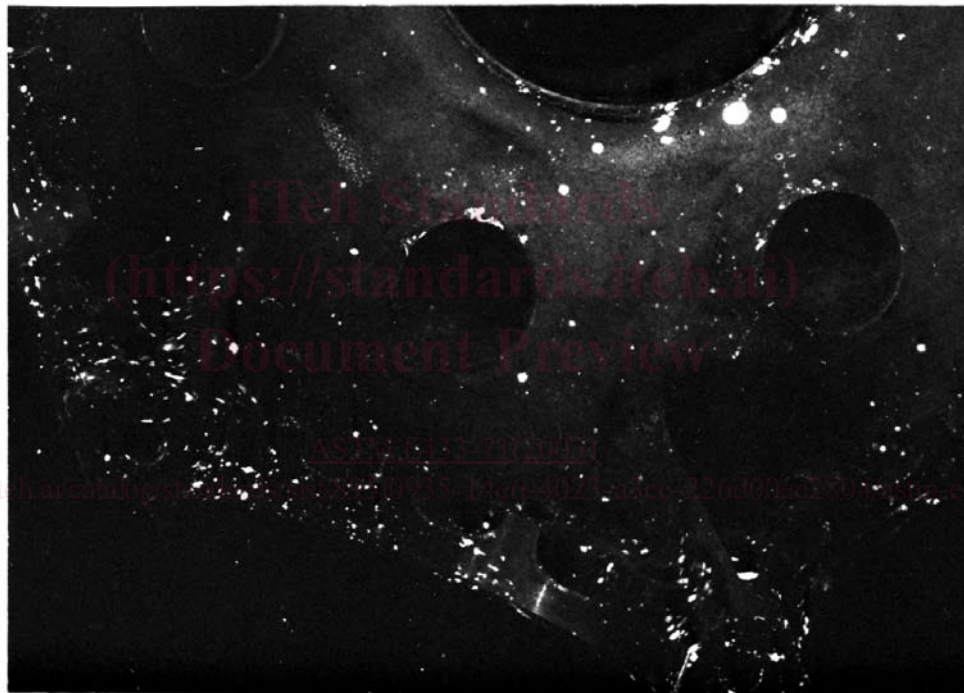
FIG. 2 Example of Type I, Class B, Indication
