Designation: F1372 – 93(Reapproved 2005)

# Standard Test Method for Scanning Electron Microscope (SEM) Analysis of Metallic Surface Condition for Gas Distribution System Components<sup>1</sup>

Semiconductor clean rooms are serviced by high-purity gas distribution systems. This test method presents a procedure that may be applied for the evaluation of one or more components considered for use in such systems.

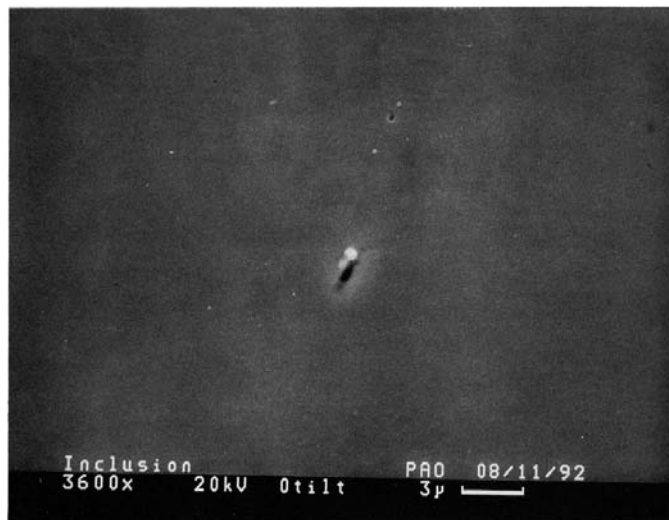
FIG. 2 Example of Pit Defect (3600 × magnification)

3.1.7 *pit*—a small, sharp, roughly circular cavity in the metal surface (see Fig. 2).
