CEN/TR 14067-7

April 2021

Railway applications - Aerodynamics - Part 7: Fundamentals for test procedures for train-induced ballast projection

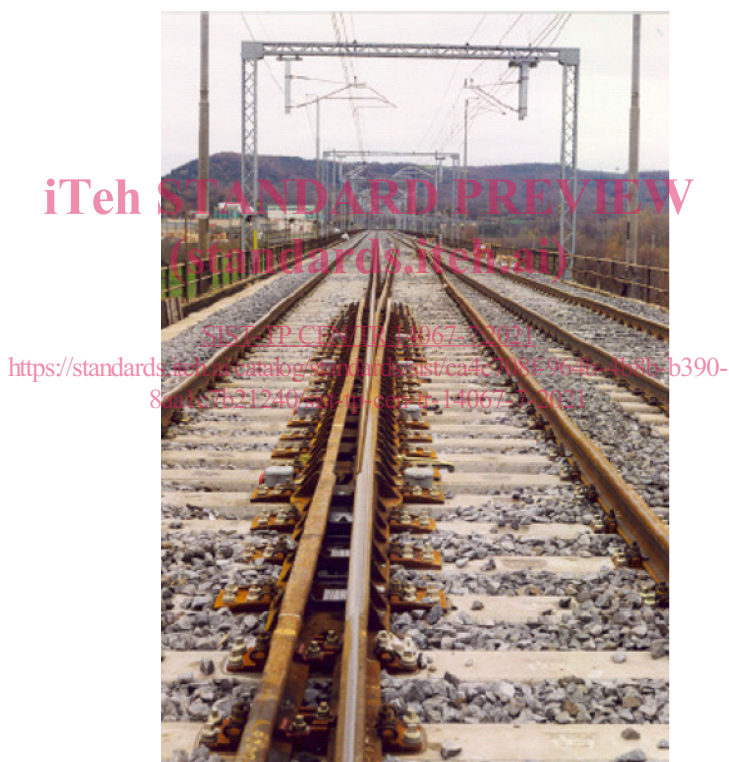
Figure 1 — Part of the Rome-Naples line at the time of the ballast projection incident in 2004, [1]

During initial runs of the ETR 500 on the then newly constructed Rome-Naples high speed line in 2004 a ballast projection incident occurred. The sleepers were of the mono-block type, as shown in the photograph in Figure 1 taken at the time of the incident. It can be seen that the ballast was not specially lowered between the sleepers, and significant amounts lay on top of the sleepers themselves.

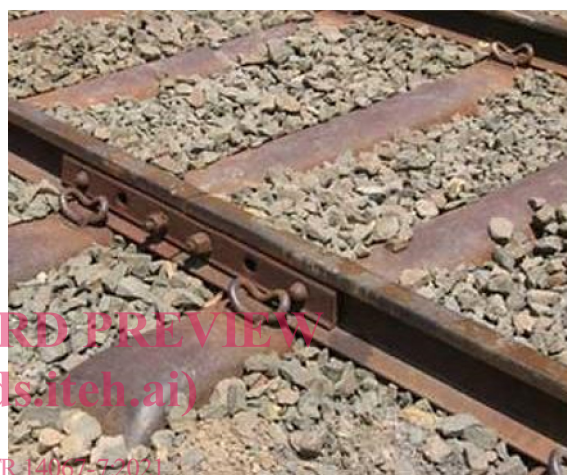
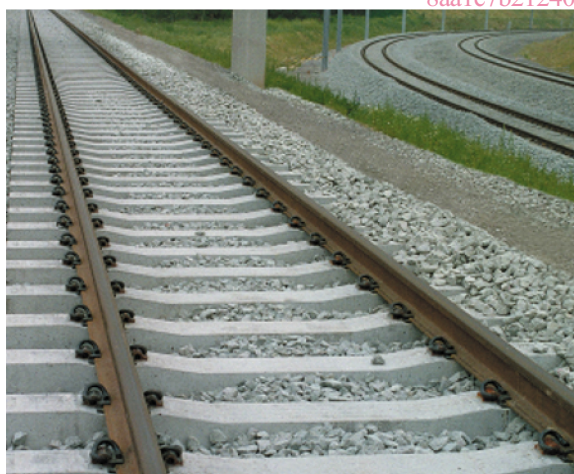
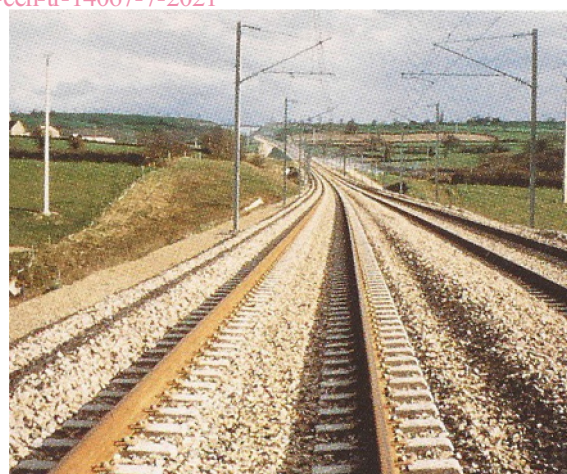
Figure 2 — Examples of railway sleeper types

a) Wooden sleepers

b) Steel sleepers

c) Mono-block sleepers

d) Bi-block sleepers

Of particular interest is the bi-block sleeper, where there is no constraint to the movement of the ballast in the direction of the train from the sleeper between the two end blocks.

Examples of the different sleepers are shown in Figure 2.

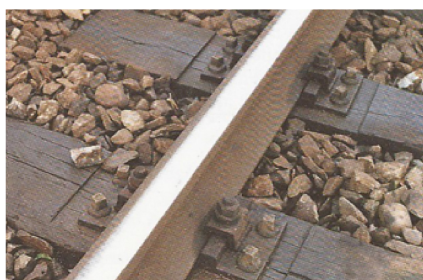
<https://standards.itch.ai/catalog/standards/sist/ca4c708f-964b-4b8b-b390-8aa1c7621240/sist-tp-cen-tr-14067-7-2021>
Figure 3 – Rail fastening systems

a) Rail baseplate

b) Pandrol clip

c) Vossloh fastening

The DE (Deenik, Eisses) clip, shown in Figure 2 a), is widely used and can be fitted on concrete or wooden sleepers. A number of manufacturers have also produced other fastening devices, such as Pandrol, Vossloh, McKay, and Nabla. These other devices are shown in Figure 3.

It can be observed that the rail fastening systems, although having differing designs, are unlikely to influence ballast movement or provide any significant impediment to aerodynamic ballast projection.

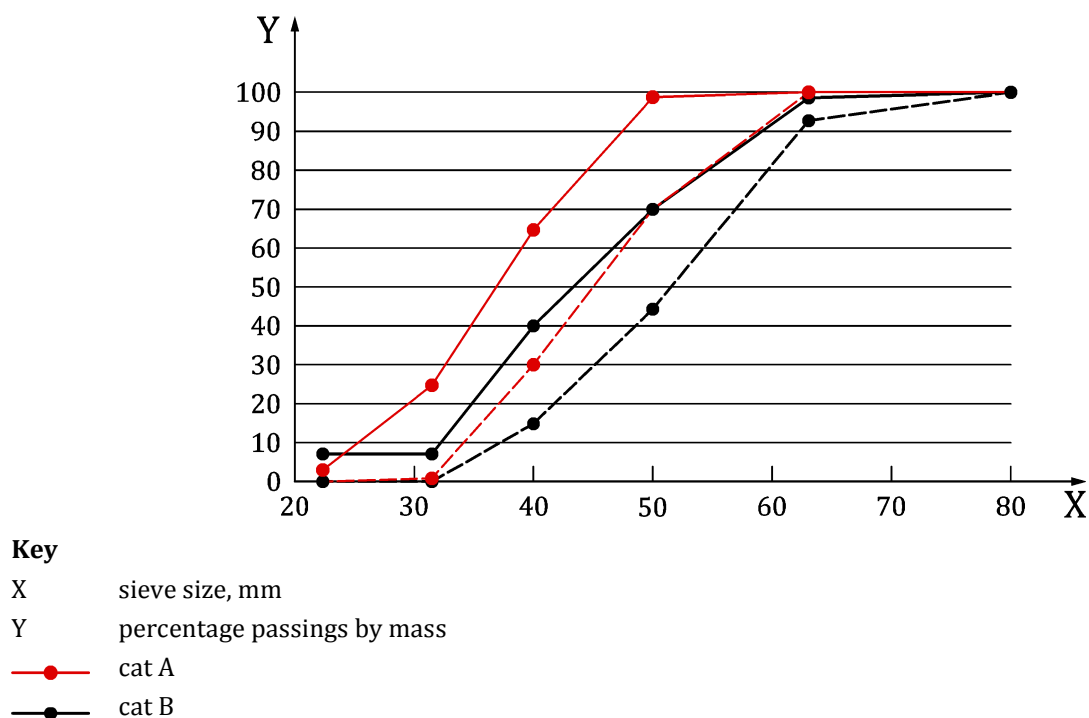
Figure 4 — Distribution of ballast sizes, Categories A and F

EN 13450:2013 *Aggregates for railway ballast* specifies a standard for railway ballast sizes. Although currently withdrawn, the standard is still referenced in company standards e.g. by Network Rail in Great Britain. Essentially, ballast is graded according to the mass of ballast which passes through sieves with holes of varying sizes. Ballast particles range between a nominal 31,5 mm up to a maximum of either 50 mm or 63 mm. Within each of these ranges there are five sub-ranges referred to as grading categories, A to F overall. Figure 4 shows grade category A in the range up to 50 mm, and grade F in the range up to 63 mm, and represents the full range of ballast sizes and distributions. For each grade category there is also a further sub-range at each sieve size, indicated by a solid line at the maximum value and a chained line at the minimum. It can be seen that most ballast particles are between 20 mm and 63 mm, whichever grade of category they are in.

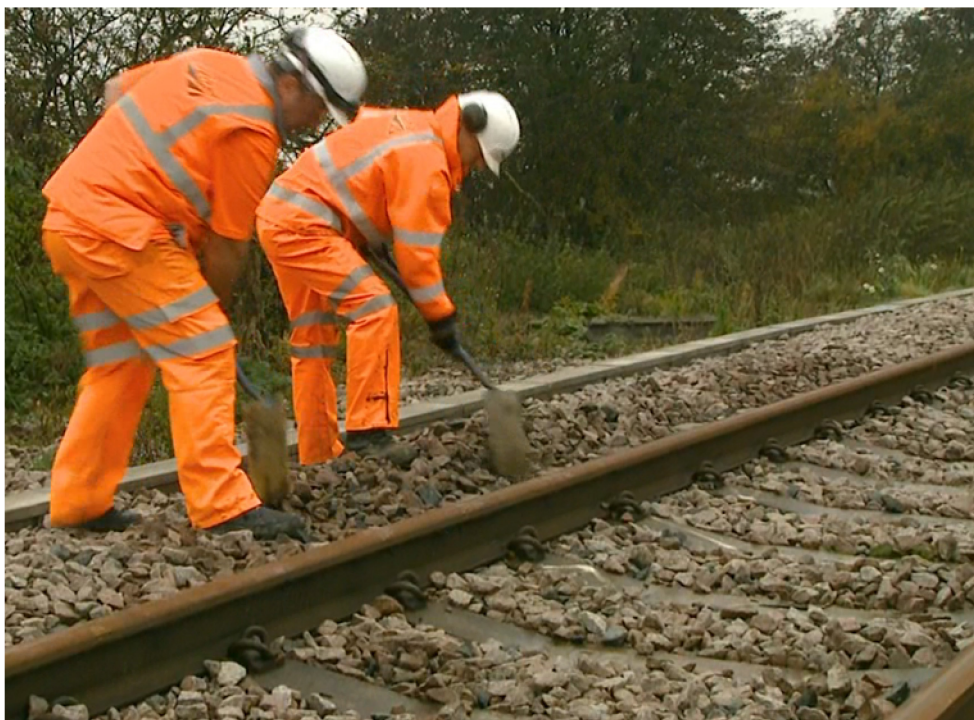
Figure 5 — Still from Network Rail video on ballast maintenance

A variety of railway sleepers are used on the standard railway lines in Great Britain. These include wooden sleepers, concrete mono-block sleepers and steel sleepers. Figure 5 shows a still image from a Network Rail ballast maintenance video; ballast stones can be seen on the sleepers, despite the commentary stating “No ballast must be left on the railhead, piled against the rail webs, over the fastenings or *loose on the sleepers*”. It is not clear if the instruction was eventually complied with in the video.
