## INTERNATIONAL STANDARD

ISO 7146-2

# Plain bearings — Appearance and characterization of damage to metallic hydrodynamic bearings —

Part 2: Cavitation erosion and its countermeasures

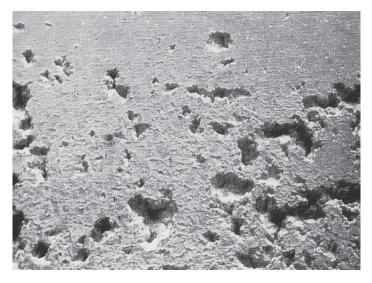
a) View under magnification

When a bearing surface is eroded by cavitation, the colour of the surface changes slightly due to roughening. Then small pores form, and cracks initiate on the surface, especially at grain boundaries. These cracks with sharp edges are spread first on the surface and then deepen according to the properties of the underlying material (see Figure 1). The cracks are joined together leading to break-out and wash-away of small particles of bearing materials.

When the damage is caused solely by collapsing cavities, the attacked areas show a rough texture. Metallurgical section often shows signs of local work-hardening and fatigue cracking due to hammer blows caused by cavity collapse. But if particles are trapped in the damage pockets, the surface can be eroded and exhibits a smooth and polished appearance. The place of cavitation erosion is usually limited locally and spreads seldom to a broader region. The cavitation erosion usually appears in the unloaded areas of the bearing.
